PUBLISHABLE SYNTHESIS REPORT

CONTRACT No : BREU-0570

TITLE : DEVELOPMENT OF REFURBISHMENT PROCEDURES OF
INDUSTRIAL COMPONENTS BY NON CONTACT
DAMAGE MAPPING AND CO₂ ROBOT-LASER WELDING
AND CLADDING

DATE: 10.12.96

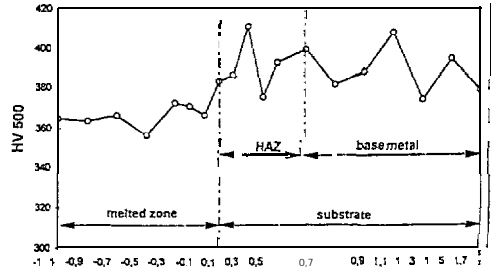
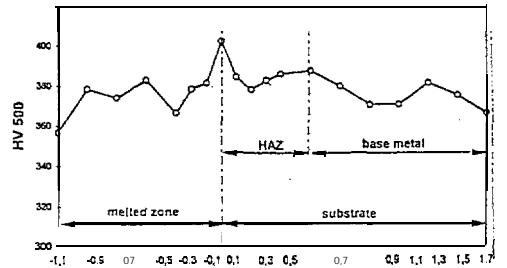
The electron beam Process was abandoned by EGT due to cost evaluation. The laser-processing **technique** gave good results (see an example in Fig. 2). Different post-weld heat treatments (PWHT) were considered to eliminate hardness peaks. LCF tests were performed: only laser welded testpieces were compared with parent material as no TIG welded samples on forged 17-4-PH could be prepared. LCF tests were performed on laser

clad forged 17-4-PH material without any Post Weld Heat Treatment (PWHT). There was a large reduction in fatigue strength when compared with parent material. These results were then compared with samples which had undergone some form of PWHT (both the full standard heat treatment, solution and ageing, and only ageing treatment) were considered. The results suggested that an improvement in fatigue strength could be gained simply by carrying out an ageing heat treatment, as shown in Fig. 3. The fatigue strength was still, however, below that of the parent material. HCF results showed a big scatter, probably due to the porosity of the weld bed.

Fig. 2- Comparison between laser-cladded 17-4-PH tests-pieces for tensile tests: a) as welded; b) PWHT.

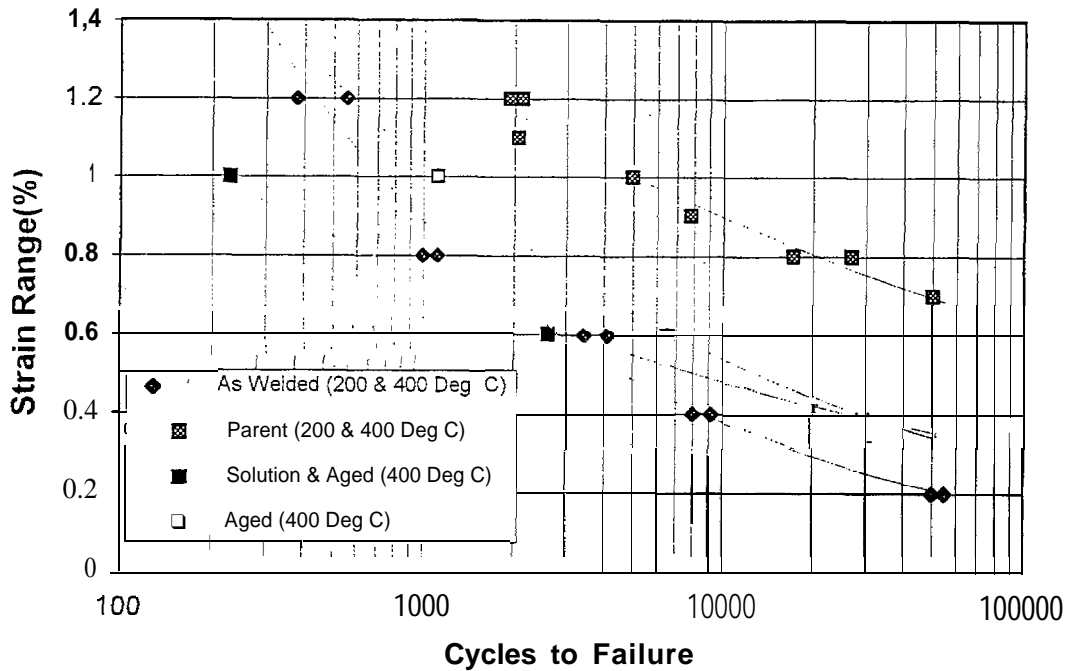
Fig. 3- Comparison of LCF properties of laser-welded 17-4-PH (with and without PWHT) with forged parent material.

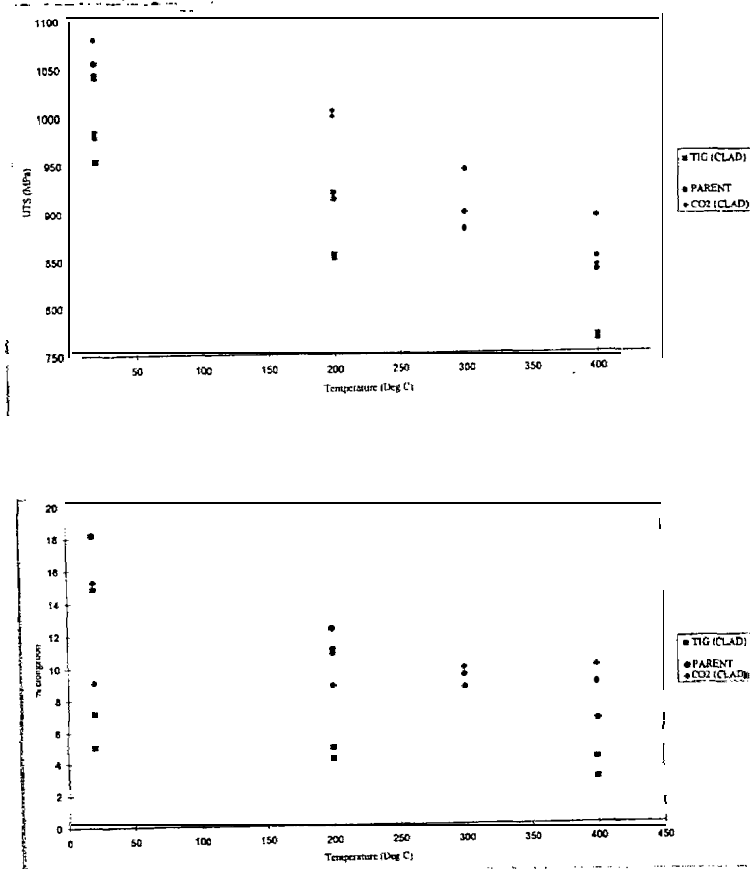
The discriminatory bend tests indicated that only TIG and CO₂ laser welding are suitable techniques for repairing this material. In Fig. 4 a comparison between the macrographs of TIG and of laser welding is shown. The tensile tests performed on the test-pieces obtained with the different repairing techniques are shown in Fig. 5. Electron Beam welding gave rather good results but was considered unsuitable due to failing in the weld in bend tests. TIG welding performed by Chromalloy was found to give slightly better results than that performed by CUK but was still lower in UTS and elongation than CO₂ laser welding. So the laser welding is the best repairing technique as tensile results are comparable to that of the parent material.

Fig. 5- Tensile tests results on Haynes 230 welded test-pieces.

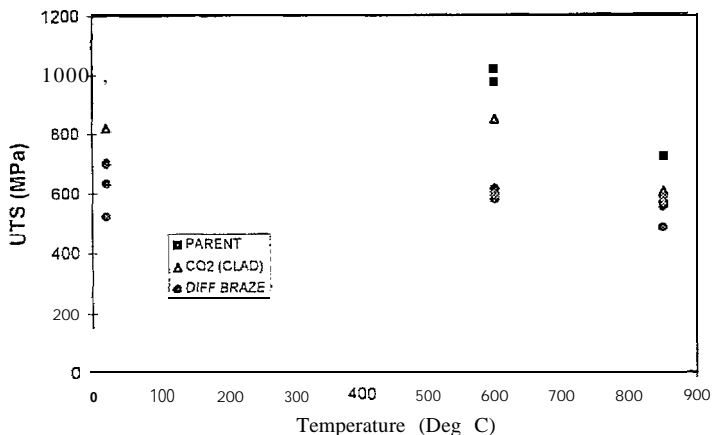
The brazing technique gave good results, but poor tensile resistance (see Fig. 6). The TIG procedure developed in the project is rather innovative and very promising, but it showed some limits on big volumes and is difficult to automatize.

Fig.6 - Results of tensile tests on IN738 test-pieces.

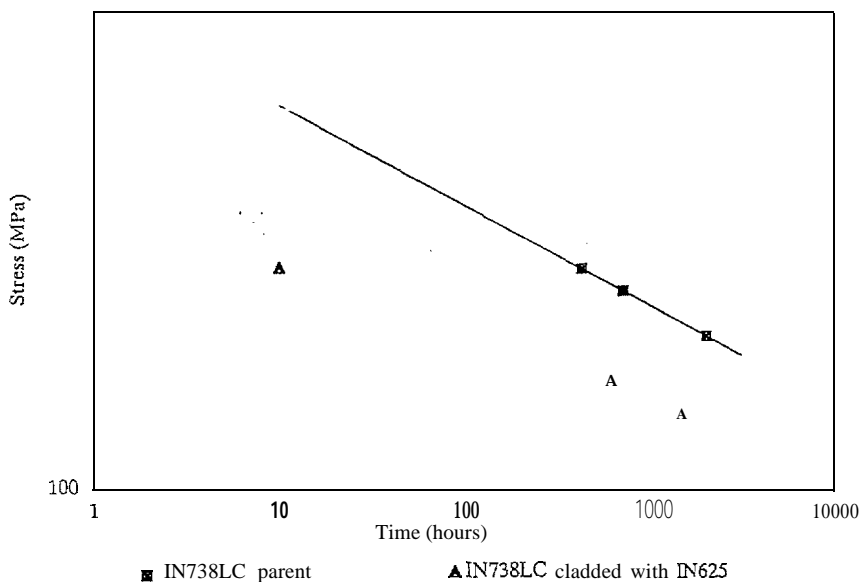
The laser processing technique was successfully applied with IN625 filler powder, even to the components (as described later), but the mechanical characterization of IN738-IN625 joints demonstrated that this solution has too poor properties to be applicable to real components of the hot section of the turbine (see for example creep rupture results in Fig. 7).

Fig. 7- Creep-rupture results on IN738 laser-clad with IN625.

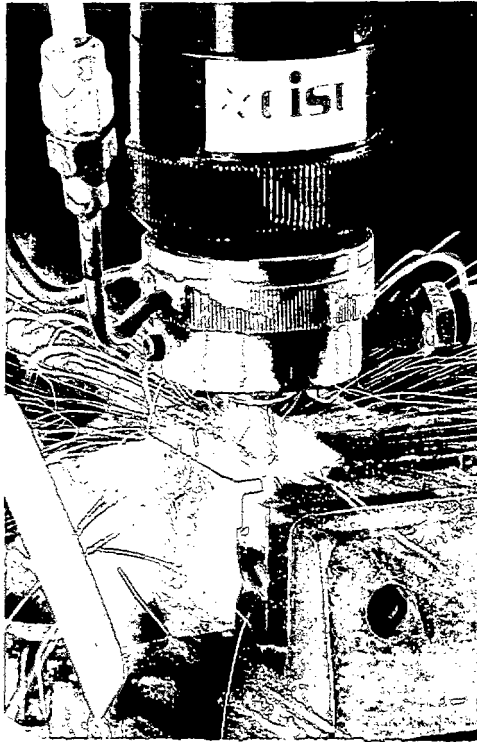
Fig. 9- CO₂ robot laser repairing of a 17-4-PH compressor blade: build-up phase of the root.

For 17-4-PH a CO₂ laser repair cycle of a real forged 17-4-PH compressor blade without any coating or oxidation film on the surface. Both the tip and the root of the blade were repaired with the optimized procedure of laser cladding. The contact damage monitoring technique was adopted for contouring and storing of damaged surface profiles (see Fig. 9 and results in Fig.10). Also the repairing of a forged 17-4-PH compressor blade by CO₂ laser welding of an insert was carried out, with the previously defined procedure.

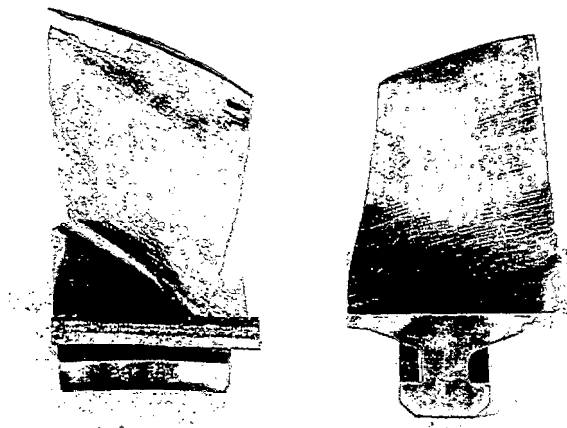
Fig. 10- Compressor blade after laser repairing and subsequent machining.

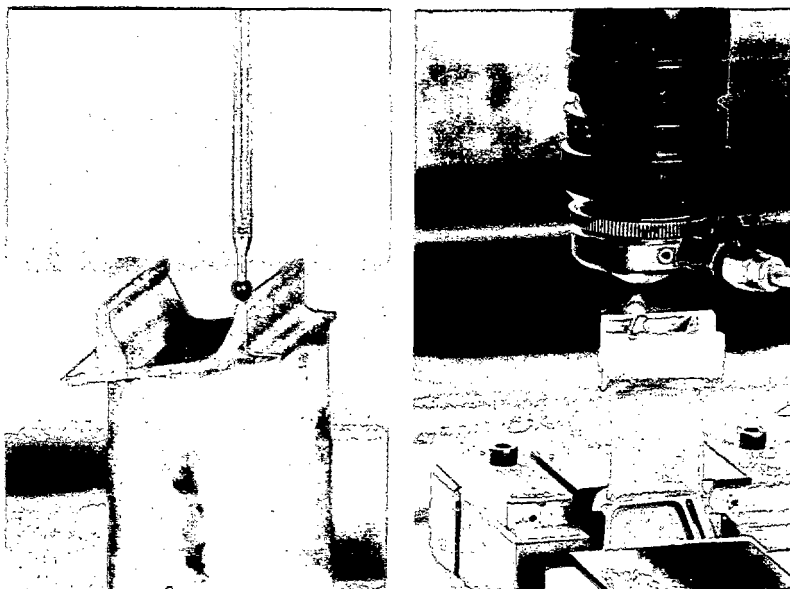
Finally the **robolaser** workstation was successfully used for monitoring damage and repairing **IN738** turbine blades with the filler metal **IN625** (Fig. 12). Actually the mechanical performances of this type of cladding are unacceptable; for the application of the automatized technology to these hot section parts it is necessary to use the procedures with the filler powder self-similar to the parent material, as studied in the Project. The

Fig. 12- Two phases of the laser processing repair of a turbine blade: a) damage monitoring; b) laser cladding.
