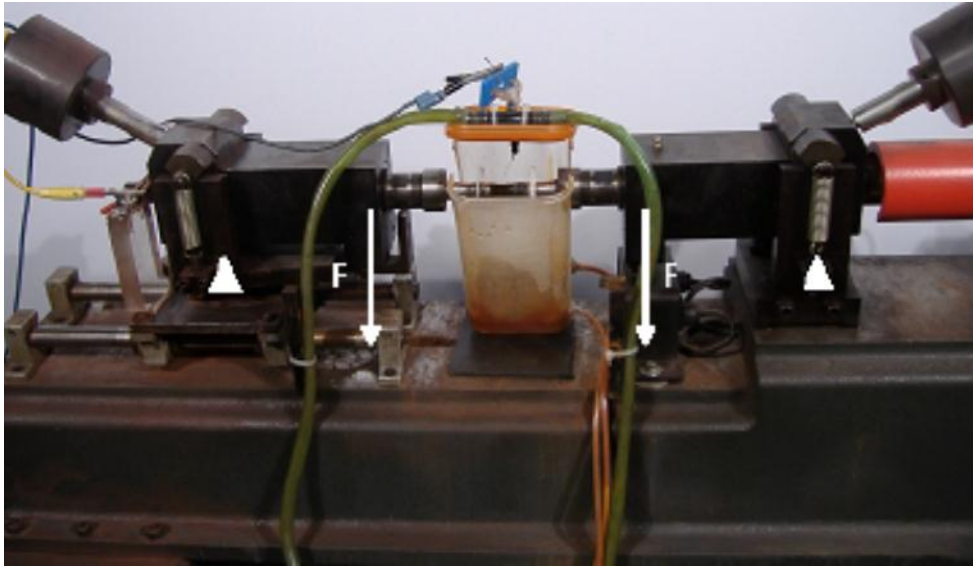
**Figure 1** Apparatus for small scale corrosion fatigue tests

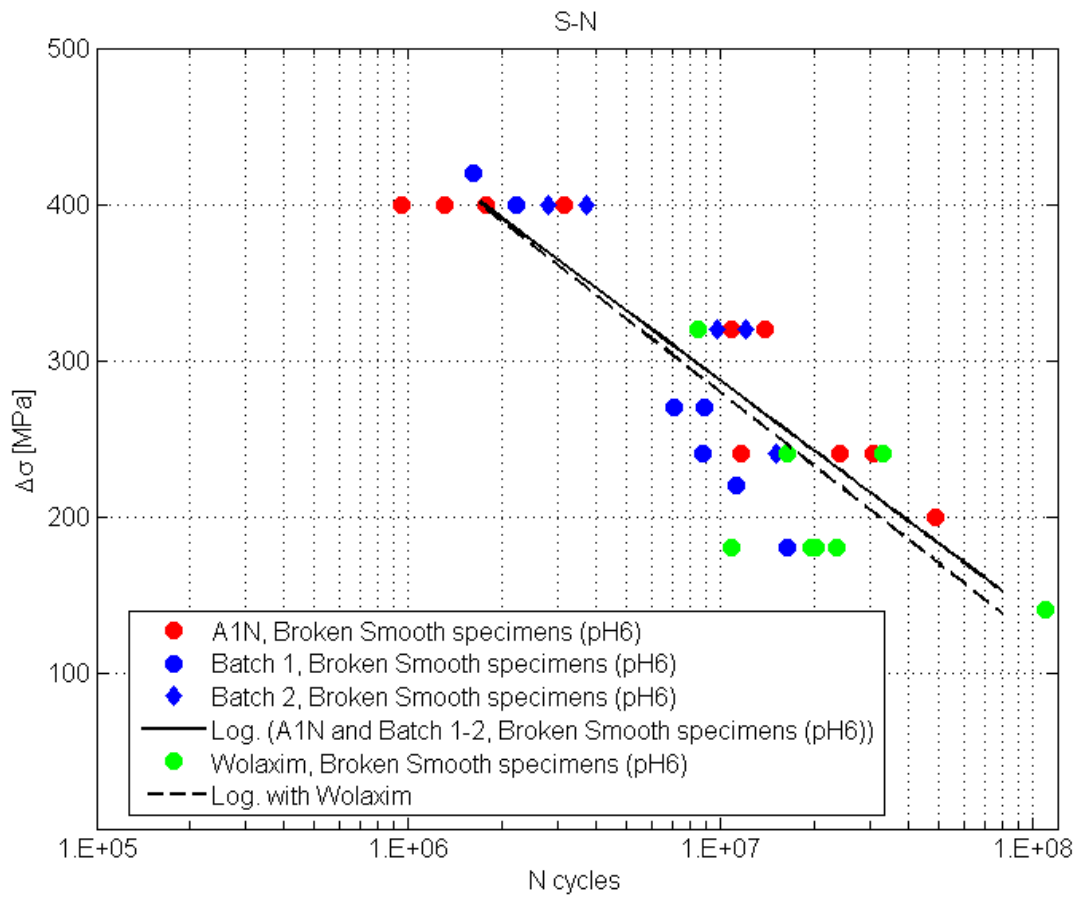
**Figure 3:** SN diagram for atmospheric corrosion-fatigue of A1N material.

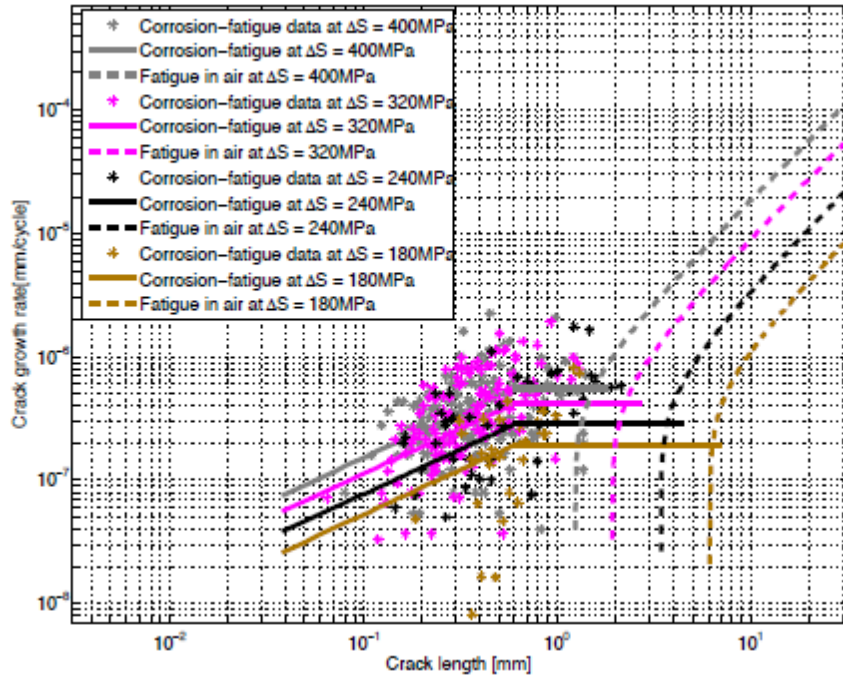
**Figure 4** Wolaxim data for comparison of fatigue crack growth in air and in corrosion conditions (A4T material)

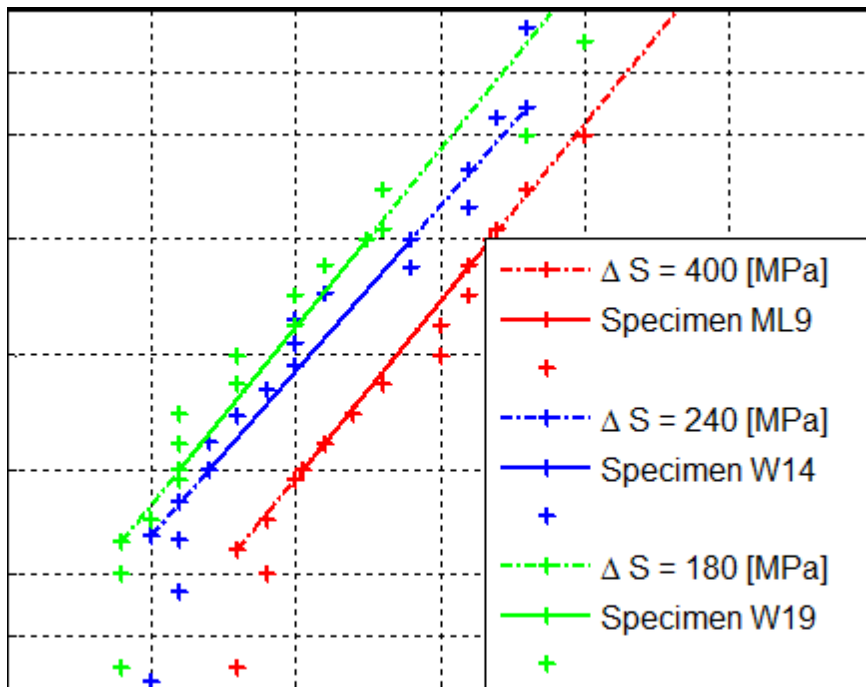
**Figure 6:** Depth of the primary pit when the secondary pit appears, varying the stress level

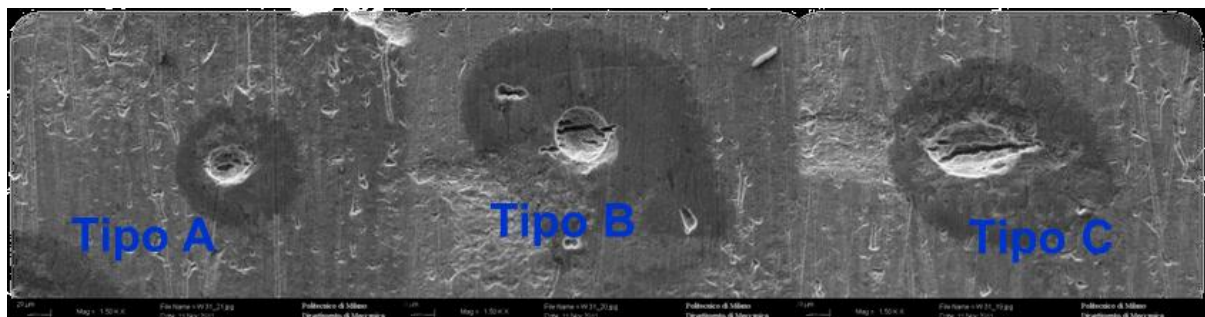
**Figure 7** Growth of Crack within a pit

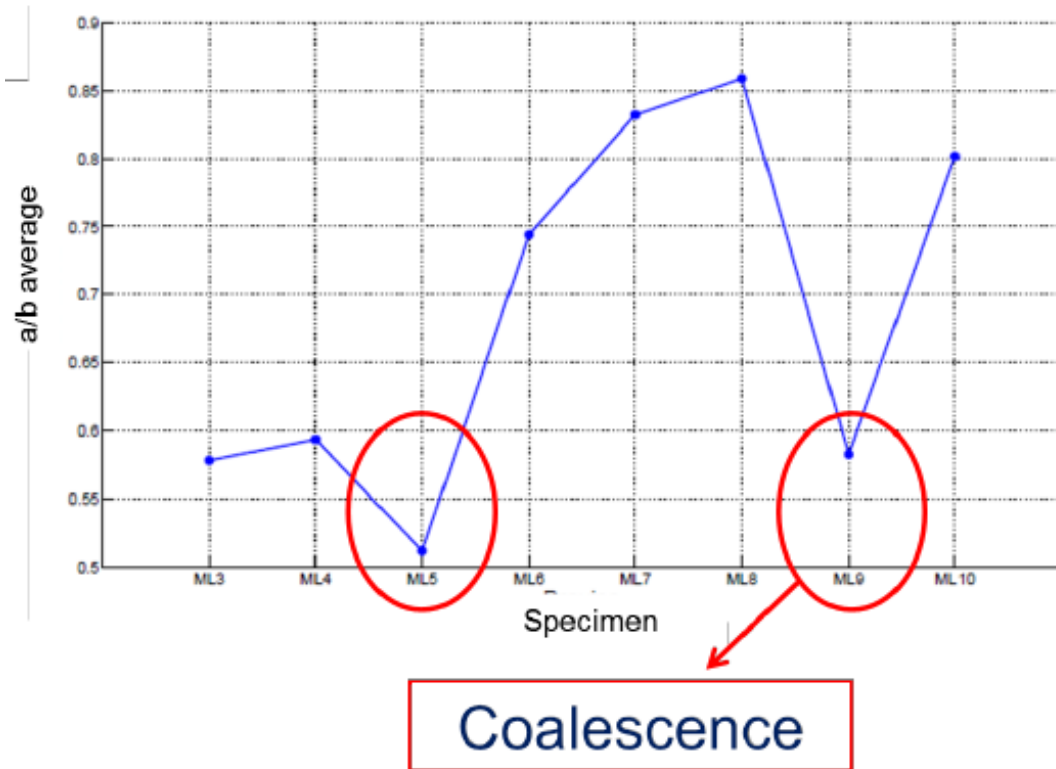
**Figure 8** Aspect ratios of cracks during a fatigue test (showing coalescence)

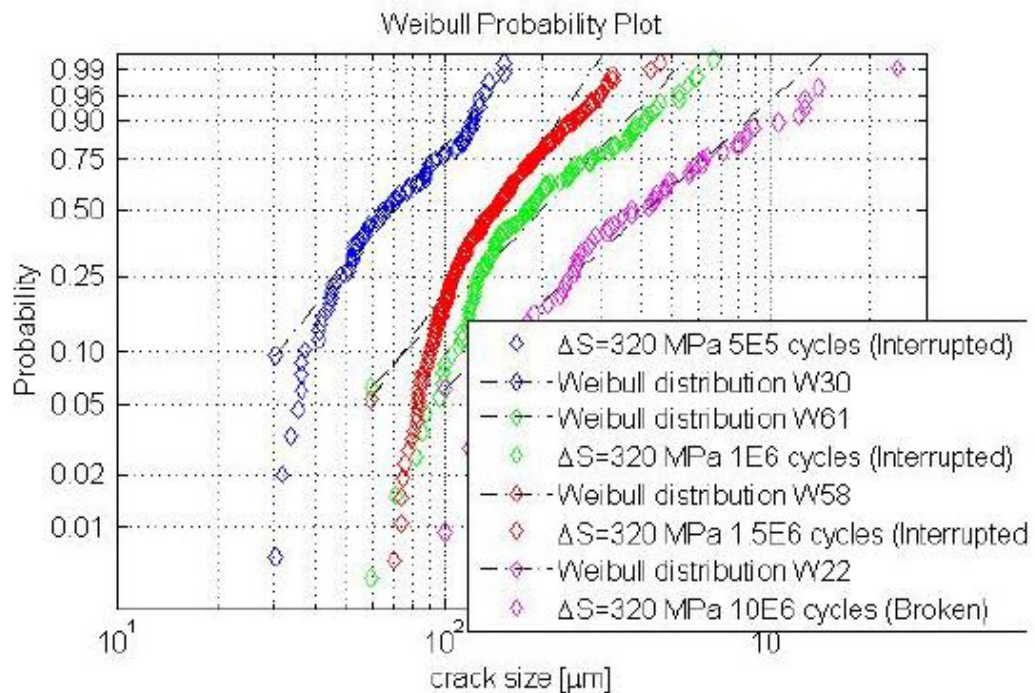
**Figure 9** Crack Length Distributions for different samples

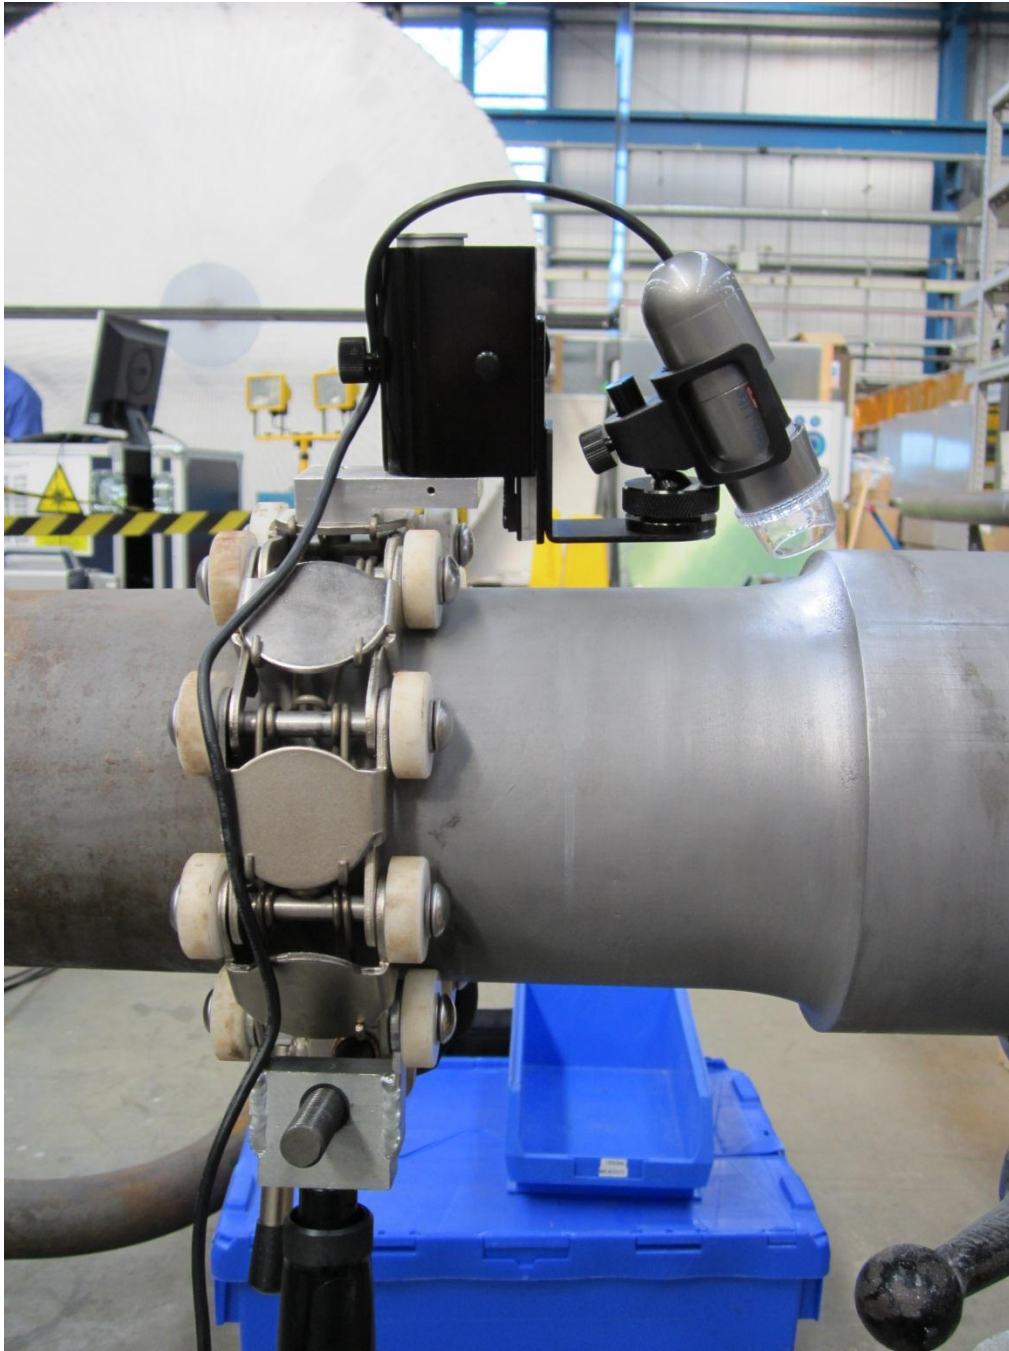
**Figure 10** Microscope, holder and scanner for corrosion assessment

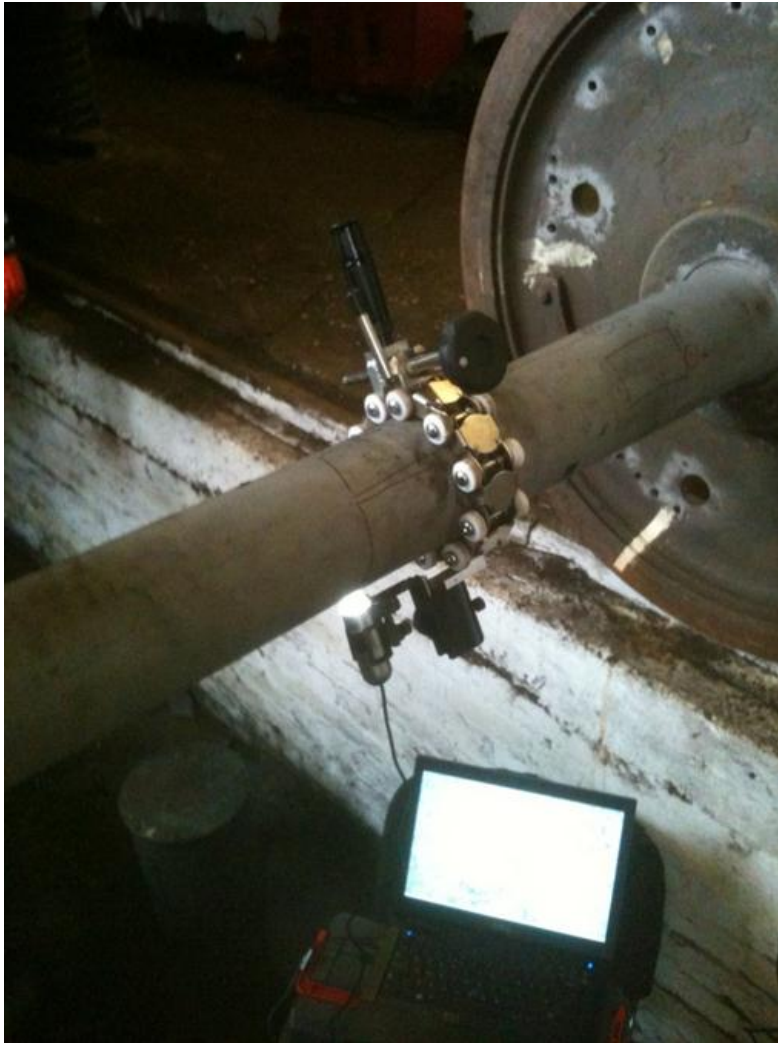
**Figure 11** System deployed in field trials

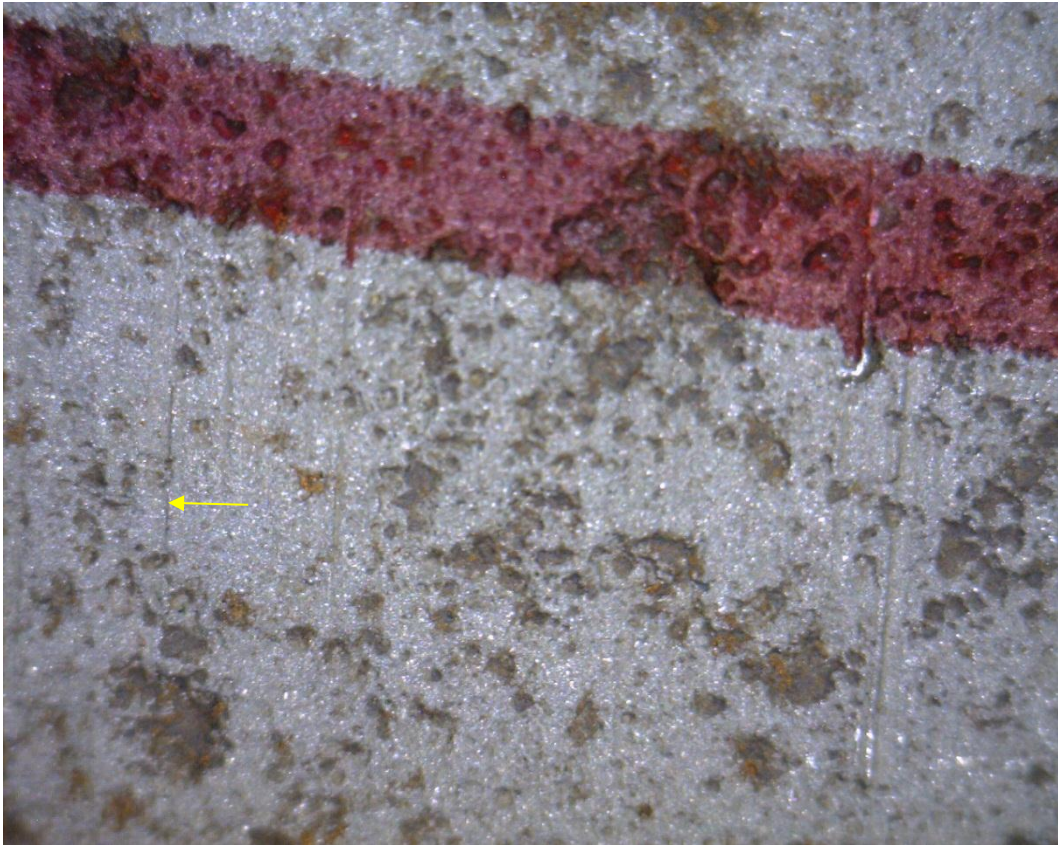
**Figure 17** Example of Cracks Detected

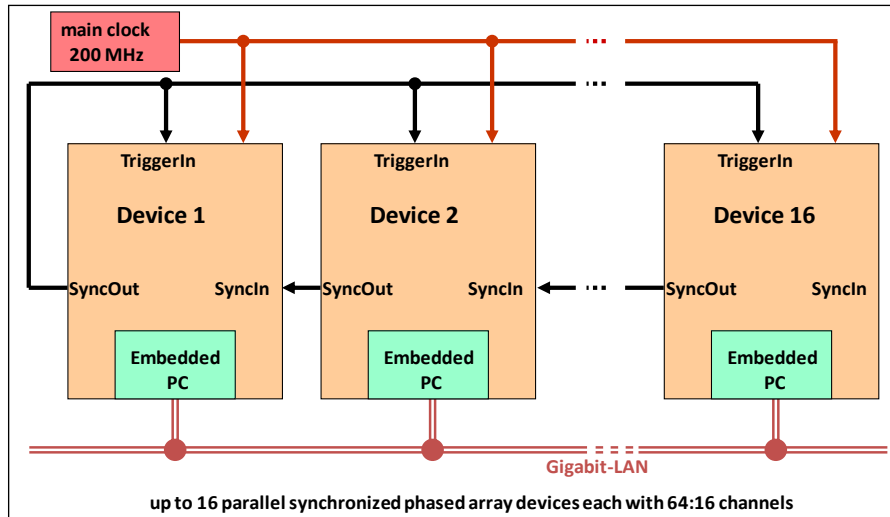
**Figure 24** Principle of the parallel operation with the COMPAS phased array device

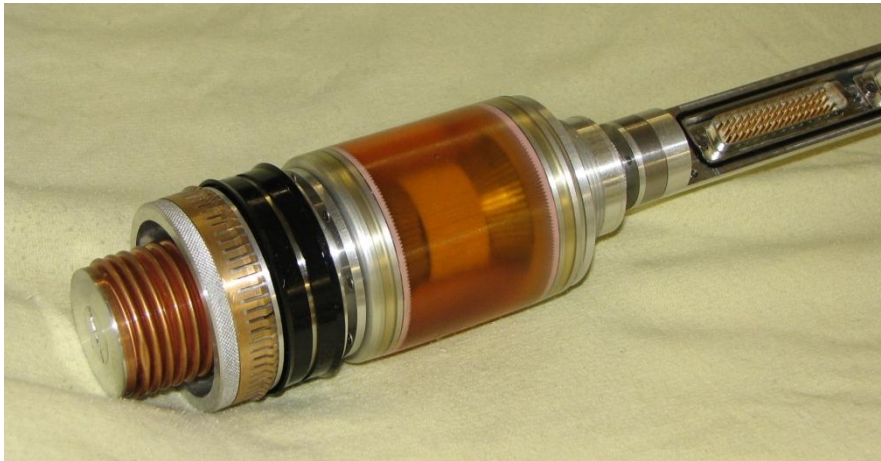
**Figure 25** Phased array probe developed in project

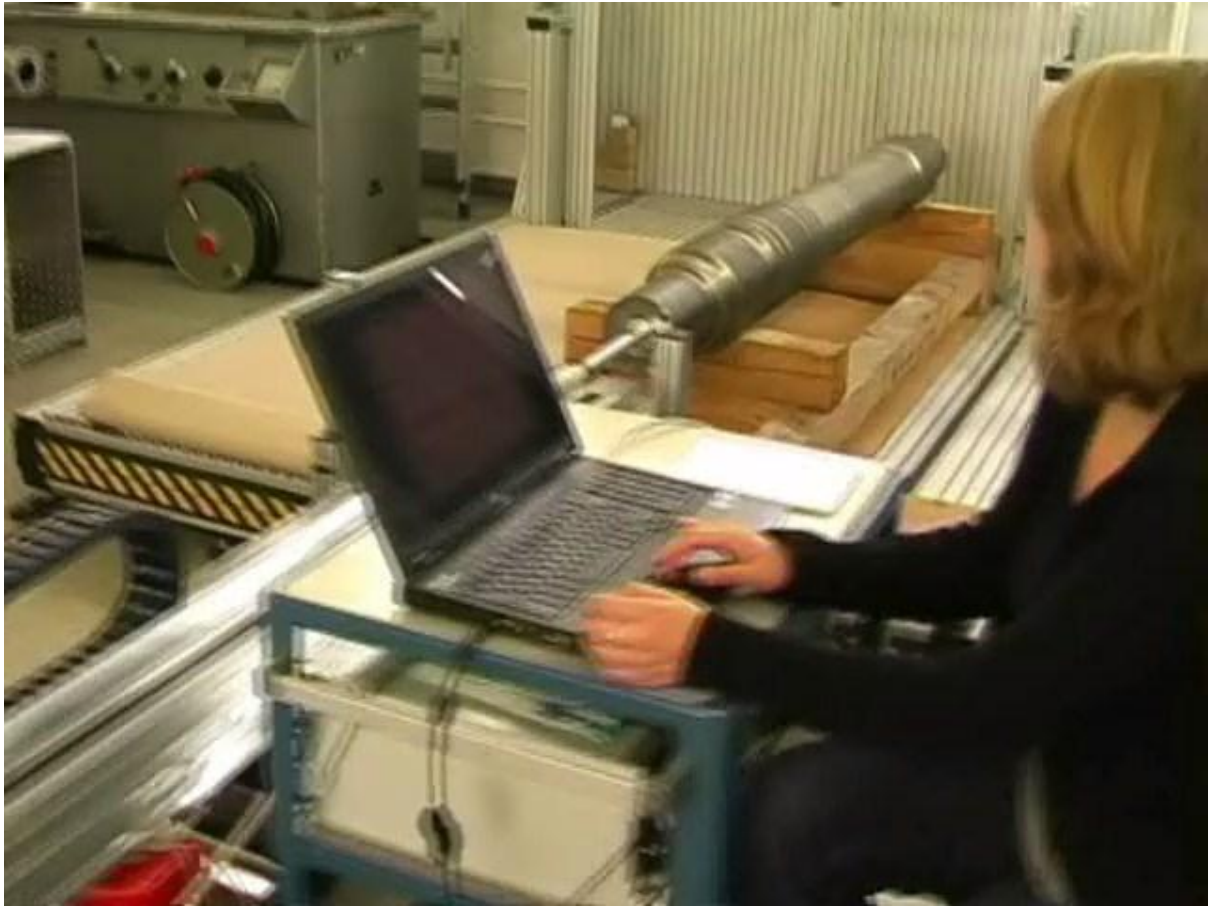
Figure 26 Experimental Test on Test Axle

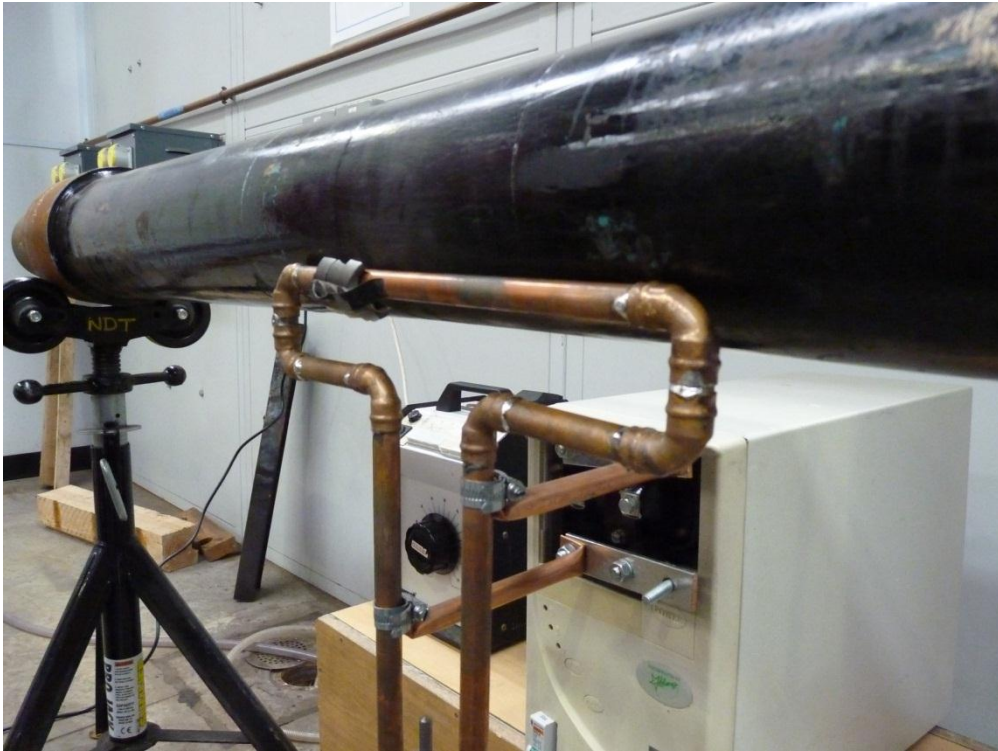
**Figure 32** 3kW unit with induction loop constructed with copper pipe

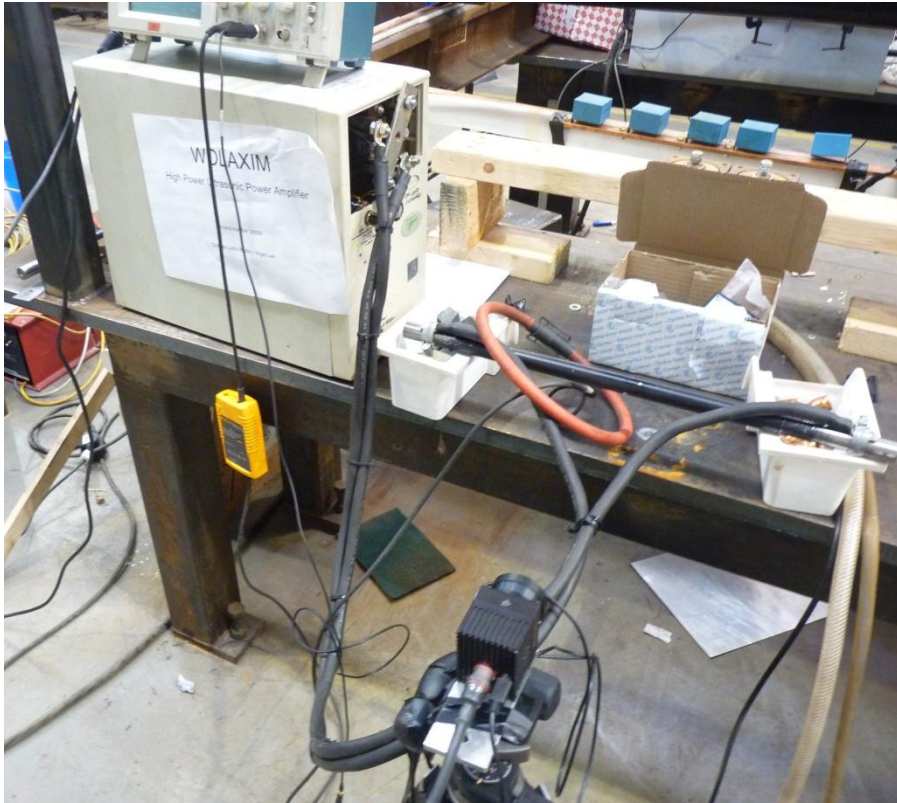
**Figure 34** 3kW system attached to small test sample by welding wires

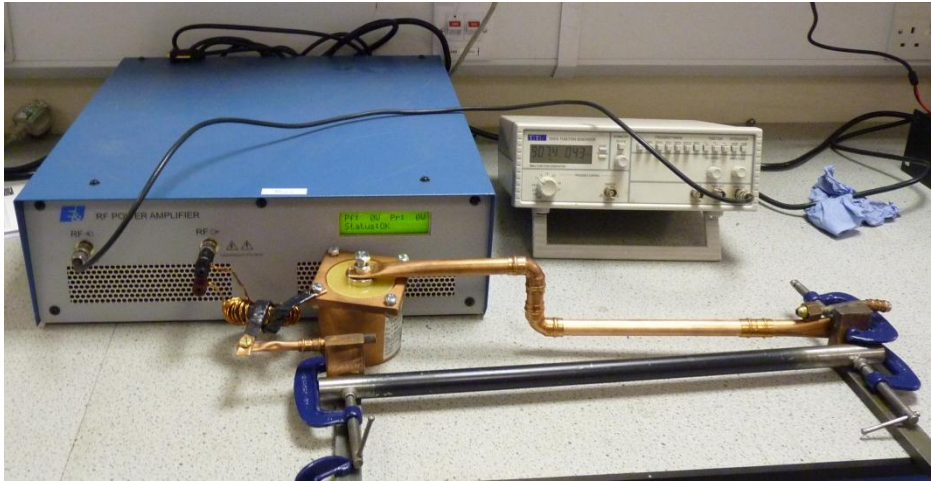
**Figure 38 (a)** Initial Feasibility Equipment

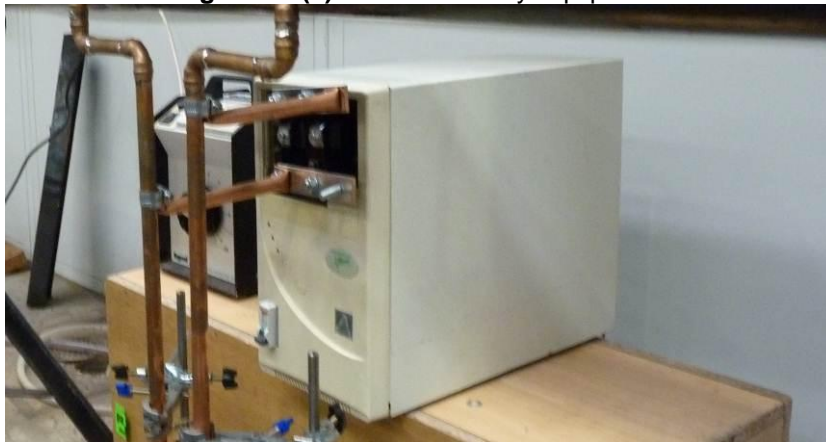
**Figure 38(b)** Prototype 3kW unit

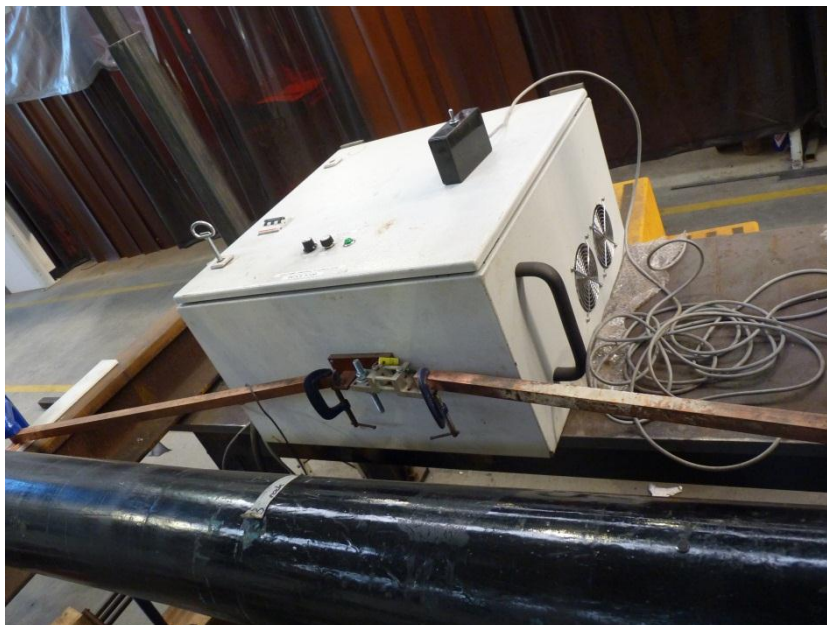
**Figure 38(c)** The finished prototype 3 phase 25kW unit

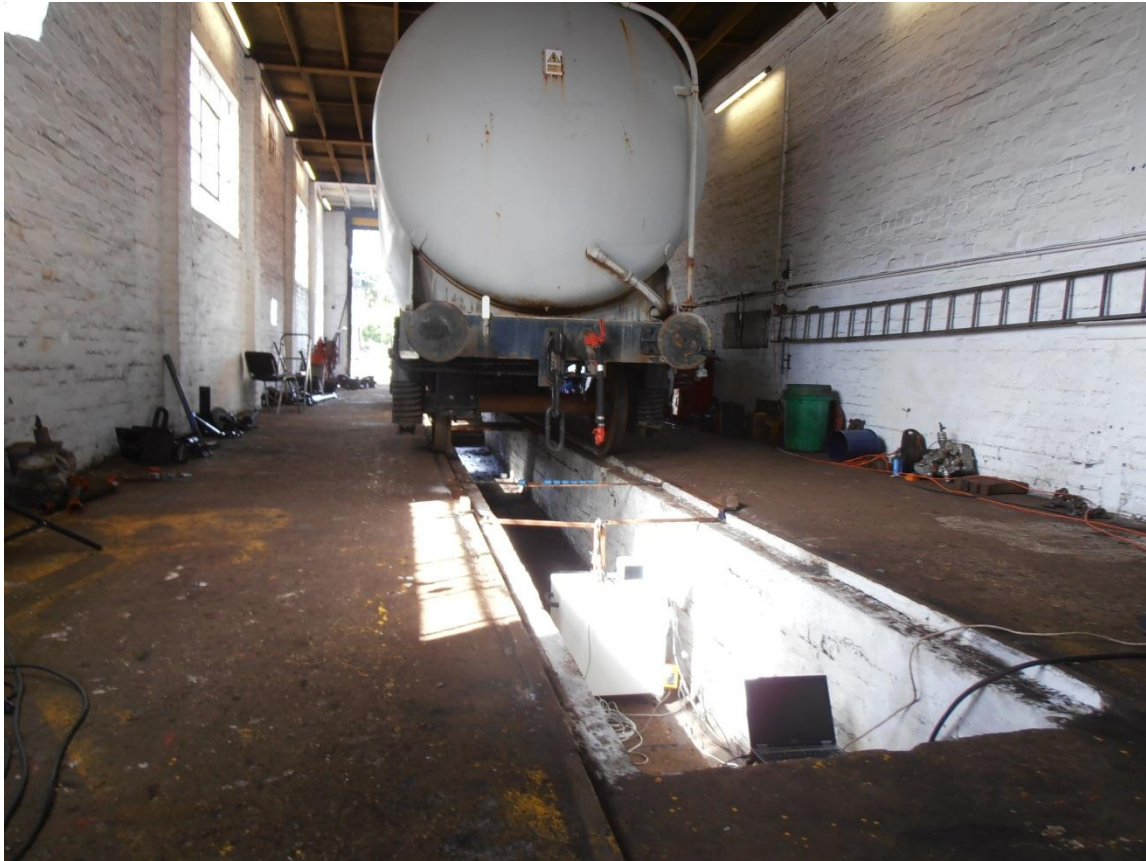
**Figure 44** Test Wagon approaching Set Up
