Figure 3: Riblet Application Areas on an Airbus A340-300 aircraft

Figure 4: General application procedure for micro-structured coatings (source: Airbus).

Figure 6: Application of first set of test patches on aircraft D-AIGH (LHT, June 29th 2011)

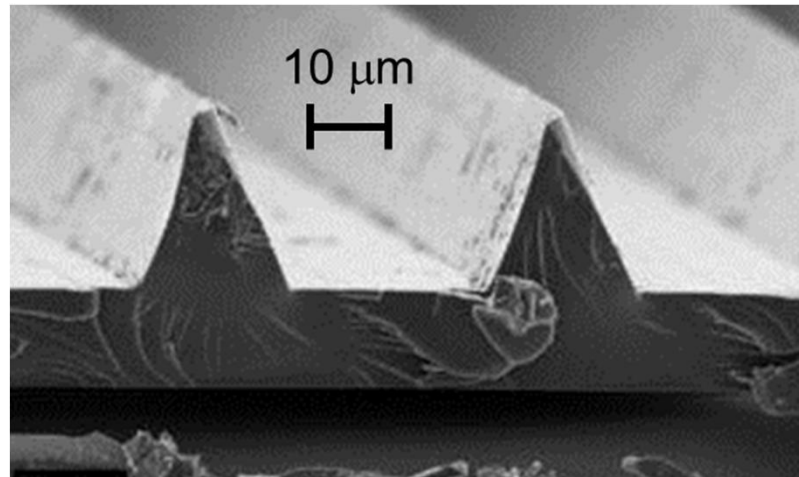
Figure 1: SEM photography of the cross section of a riblet structured surface (Fraunhofer IFAM, source: Internet)

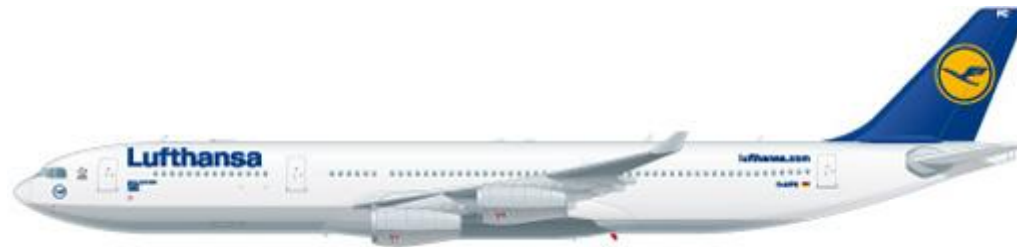
length	63,7 m
wing span	60,3 m
height	16,9 m
max. speed	875 km/h
max. flight level	12.500 m
max. take of weight	271.000 kg
max. range	12.700 km
seats	221

Figure 2: Characteristics of Airbus A340-300 aircraft

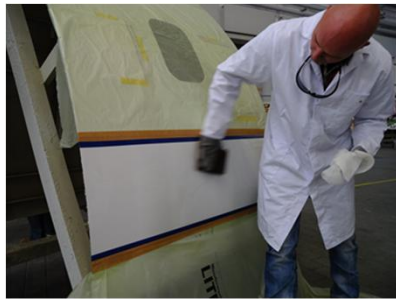
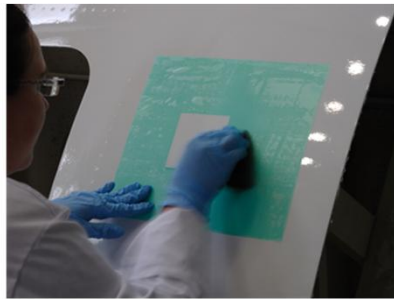
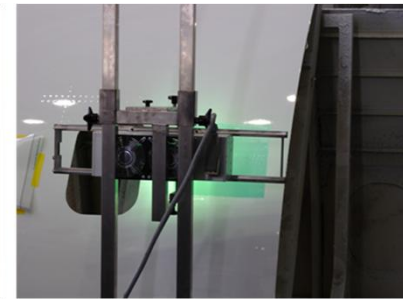
a. Preparation of test wall

b. Application of stencil and paint

c. UV hardening process on test wall

Figure 5: Trial of patch application process at a test wall at Lufthansa Technik (2011).

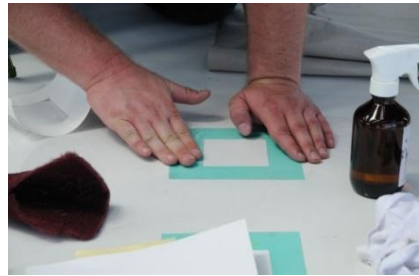
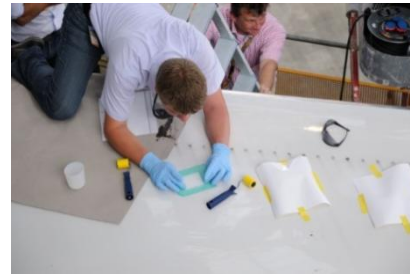
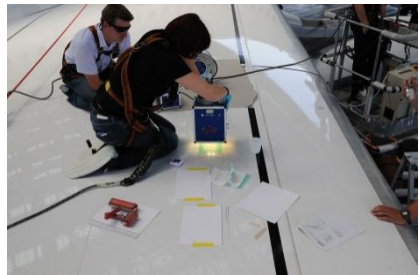
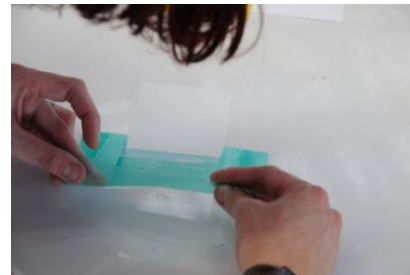
a. *Cleaning, application of stencil on pre-defined spot*

b. *Application of paint material*

c. *Embossing of riblet structure and UV hardening*

d. *Removing of stencil; riblet test patch is ready*

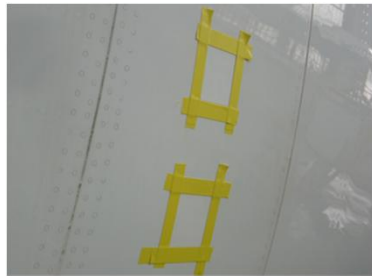
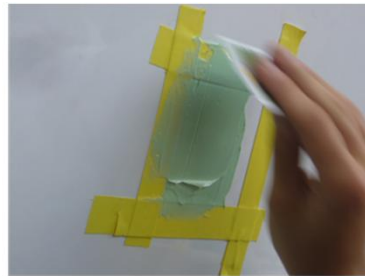
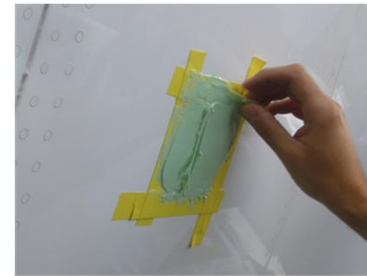
a. Marking the patches

b. Application of silicone paste

c. Peeling off paste after curing

Figure 7: Principles of De-Moulding Process of the Fuselage Patches
