The aim of the STRAINMON project was to develop methodology procedures needed for the implementation of an SHM system, based on FOBG sensors and/or standard strain gauges (SGs), onto/into a CFRP fuselage stiffened panel as well as to implement the system. The role of the FOBG sensor system is to monitor the structural integrity of impacted and fatigued panels under compression loading. The FOBG and/or SG sensors were placed (embedded or bonded) at various locations into and/or onto the structure.

Aim of the STRAINMON project was to develop methodology procedures for the implementation of a SHM system, based on FOBG sensors and/or standard strain gauges (SGs), onto/into a CFRP fuselage stiffened panel as well as to implement the system. The role of the FOBG sensor system was monitored the structural integrity of impacted and fatigued panels under static compression. The FOBG and/or SG sensors were placed (embedded or bonded) at various locations into and/or onto the structure.

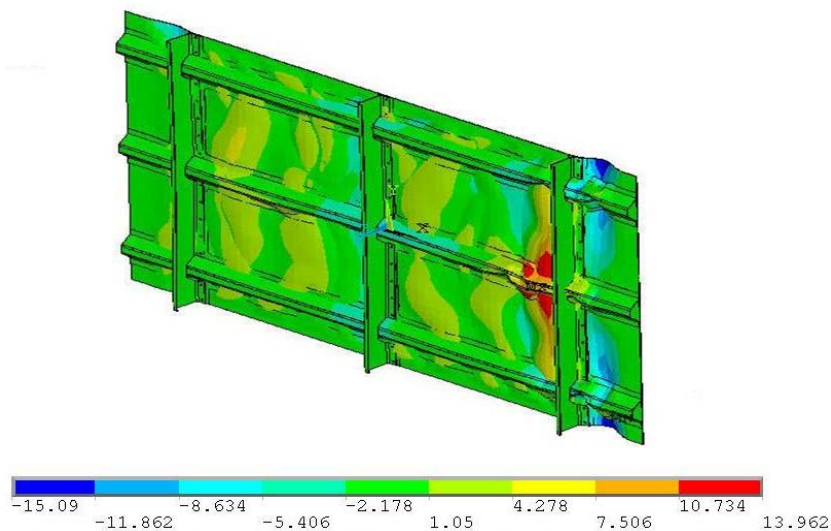
Predicted initial local buckling occurs in the bays at the moment when the load achieved 75kN in force. The behaviour of the panel is almost linear with a small non-linearity at the 250kN which is due to the change of the local buckling modes in the bays. Final failure of the panel is predicted at 473kN due to the buckling of the middle stringer at the area close to the loaded side. Fig. 1 shows the contour of normal displacement (in mm) of the panel at 473 kN.

Fig.1: Contour of normal displacement (in mm) of the panel at 473kN.

From the load-displacement curve and the observed buckling modes of the panel, it is concluded that the FOBGs should be placed at the middle of the bays in order to capture early bulking as well as the change in the buckling modes. Special attention should be given at the bays close to the loading side.

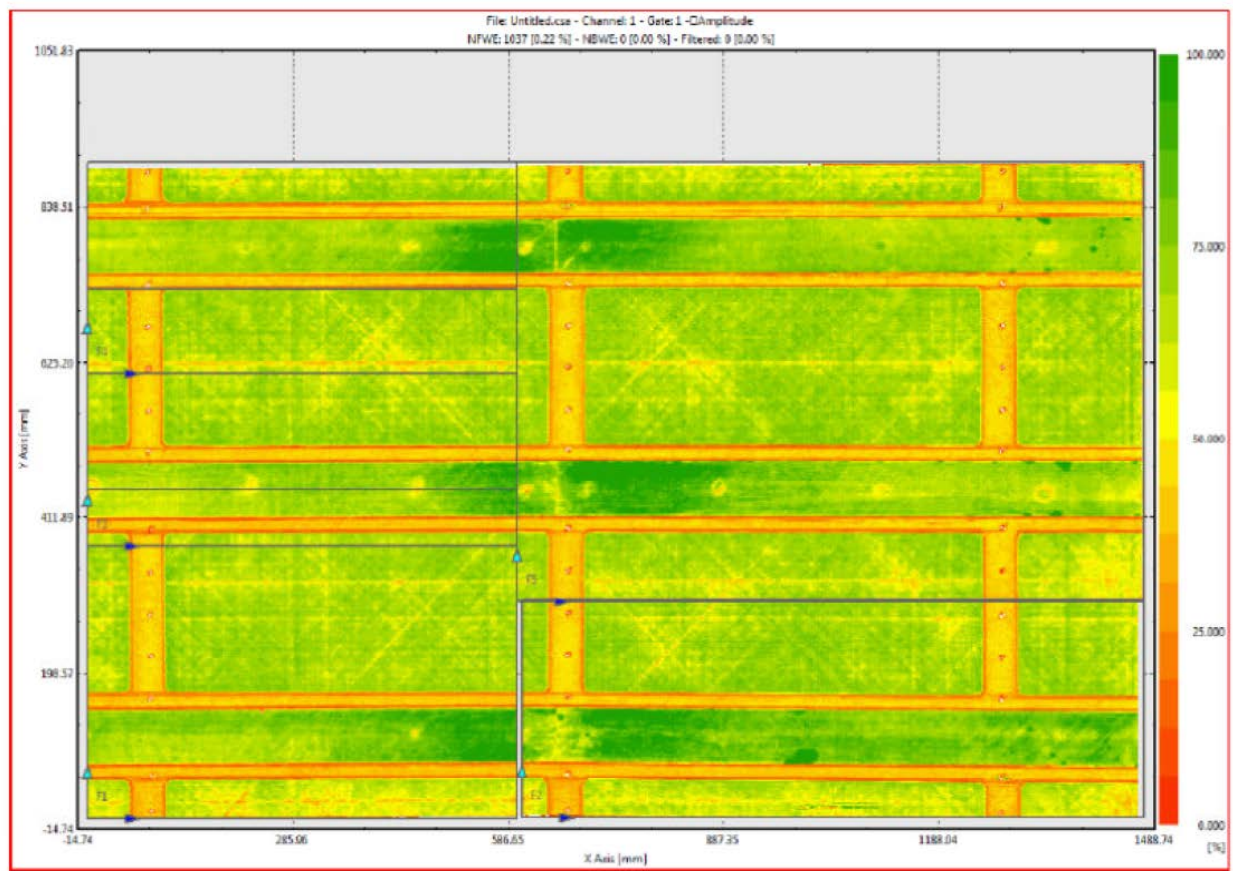
The example of NDI results for reference panel 1 without defects is shown in Fig.2.

Fig. 2: C-scan image of reference panel 1.

A standard Non Destructive Inspection procedure (C-Scan) has been performed after the end of the manufacturing process for each panel so as to access the quality of manufacturing. The type of inspection was immersion Pulse / Receive on the entire part with A-Scan and C-Scan data acquisition and presentation. Inspection after manufacturing was performed by a UT-Level 1 Inspector. Tools and equipment used:

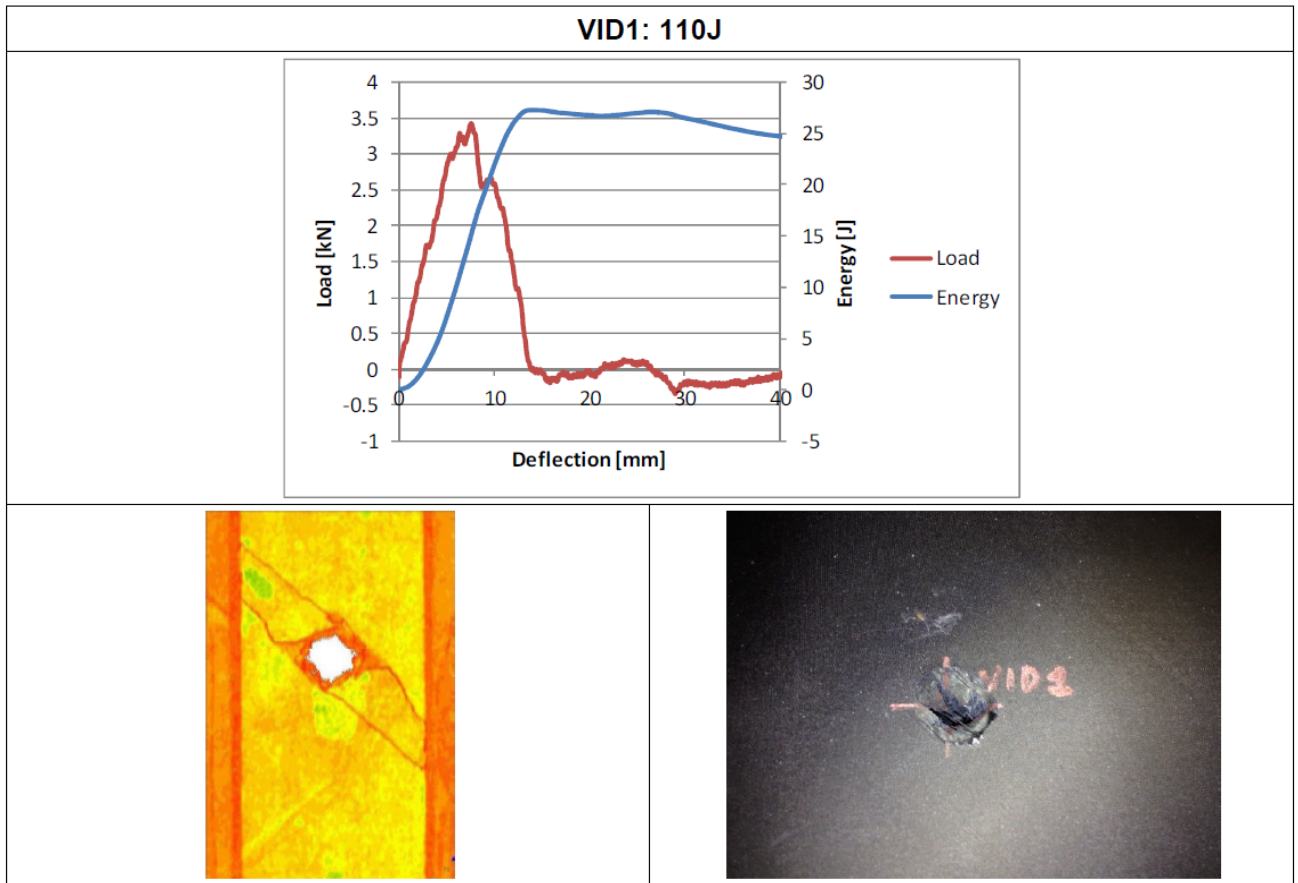
Low velocity impact tests have been performed using the mass-drop method. To this end, the INSTRON DYNATUP 9250HV drop tower has been used. Impact tests have been performed using a semi-circular impactor with a radius of 16mm. Fig. 3 shows the example of impact test results and NDT inspection results after impact.

Fig. 3: Example of impact damage and NDT results for 110 J energy

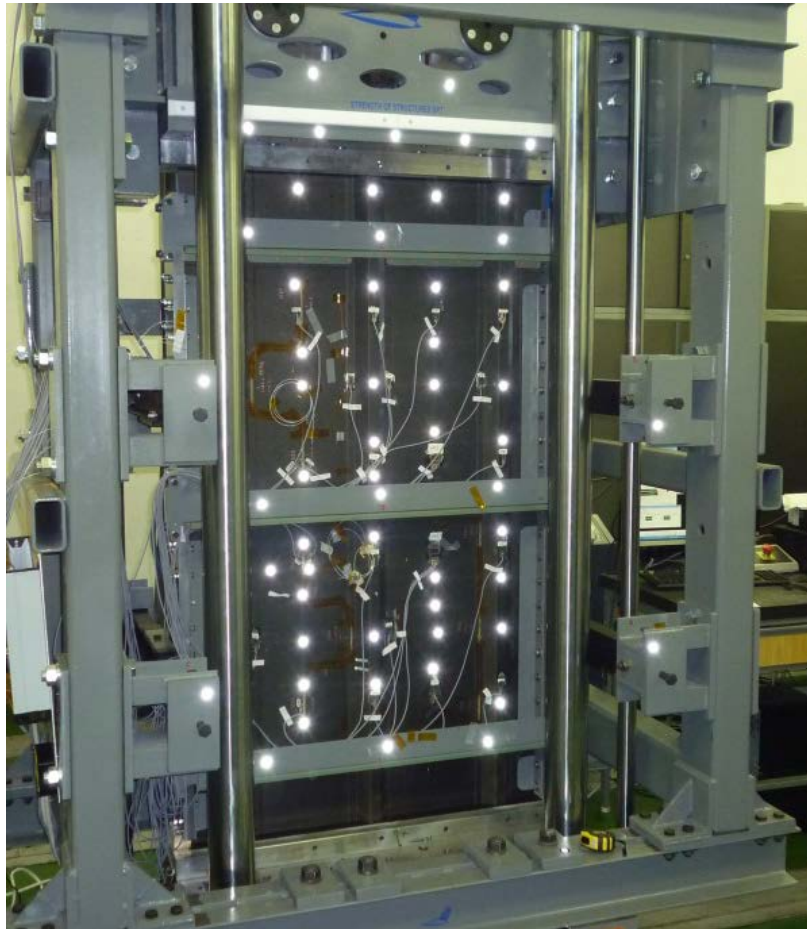
location in the test frame was positioning of the neutral axis of bending. The antibuckling device configuration with the panel and all used sensors (FOBG, SG, and points for optical measurements) is shown in Fig. 4.

Fig. 4: Panel test configuration

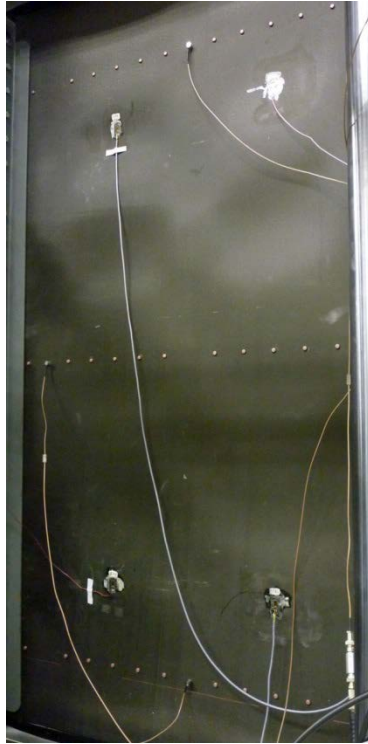
The actual maximum failure load of the reference panel 1 is about 20% lower than the predicted failure load by HAI. The predicted stiffness of this panel is also higher than actual value. The rate of the actual and predicted displacement compared at the same force differs about 20%. Fig. 5 shows the buckling mode at 70% of predicted failure mode.

Fig. 5: Panel 1 reference – skin side view to the panel with buckling waves (70% of predicted failure load).

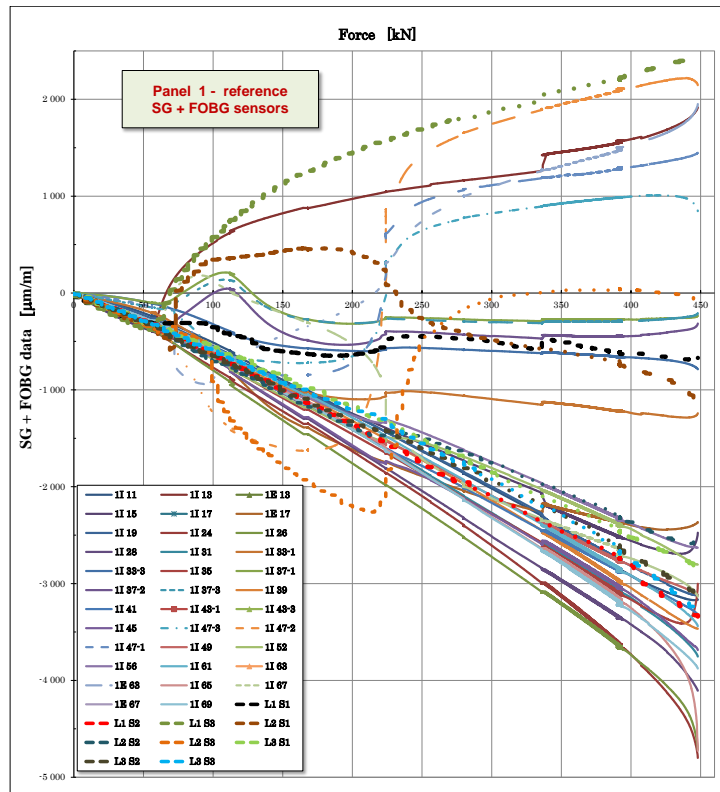
Different buckling behaviour was noticed during loading for different static sessions of individual panels. Various buckling waves initiation was observed during the preload up to 20% and following unload to zero with comparison of the subsequent loading up to 70% with following unloading to zero and finally up to failure. Three subsequent static loadings in the scale up to 20% predicted failure load of the reference panel No. 1 were conducted with the aim of deformation evaluation. No differences and permanent deformation between the static phases occurred. On the contrary some of strain gauges behaviour is totally different in the phase of the first loading up to 70% of predicted failure load with comparison of the second loading up to 70% of predicted failure load. Several changes in buckling modes have been identified during loading of the panels using the optical deflection measurements of PONTOS. A significant damage occurred in panel 1 during a buckling at 49% of the predicted strength by the first static loading. It influenced the buckling state of the second static loading to failure. Comparison of all SGs with FOBG sensors data of reference panel 1 is shown in Fig. 6.

Fig. 6: Panel 1: comparison of FOBG and SGs vs. force data (up to failure load application).

SG's and FOBG's sensor pairs were chosen according to their matching location to compare whether they correspond in measured strain values. The ability of FOBG sensors to copy an SG strain trend is shown in the following chapters. FOBG data corresponds to SG's data trend for the sensors positioned on/in a stringer. However, the values do not correspond for the sensors positioned on/in the skin in general. Some of these differences are discussed in the following chapters. But it is surprising that almost all FOBG sensor placed on the skin analysed very low strain values.

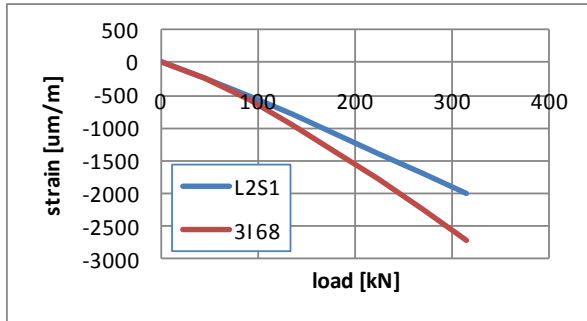
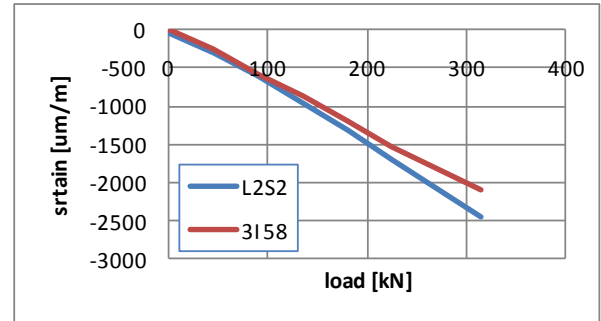
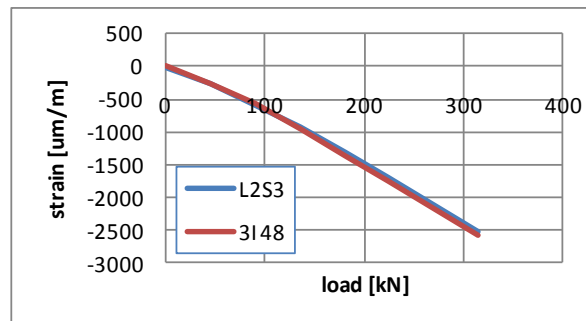
The first nonlinearity during the static sessions of panel no. 3 with VID was recorded approximately at 38 kN. The strain gauges record is repeatable in each phase of the static session. Fig. 7 shows the comparison between the FOBG and SG data placed in the stringers area of panel 3 with VID.

Fig. 7: Panel 3 VID: a) FOBG L2S1 vs. SG 3I 68; b) FOBG L2S2 vs. SG 3I 58; c) FOBG L2S3 vs. SG 3I 48; strain comparison for up to failure test phase (all sensors are placed on the stringer).

The comparison between the FOBG and SG data placed in the stringers area of panel 3 with VID shows some differences between data of FOBG and SG placed on the stringers areas. The differences between SG and FOBG can be caused by the different positioning of particular sensors through to thickness and correct positioning of sensors. FOBG sensors are placed inside in composite skin on the other hand the SG are place on the surface of skin. Moreover the actual location of FOBG sensor is not so easy to define. Based on the results analysis can be deduced that the FOBG sensor is embedded near the outer skin surface.
