**Project n°AST3-CT-2003-502907**

**Project acronym AISHA  
Aircraft Integrated Structural Health Assessment**

**Publishable Final Report**

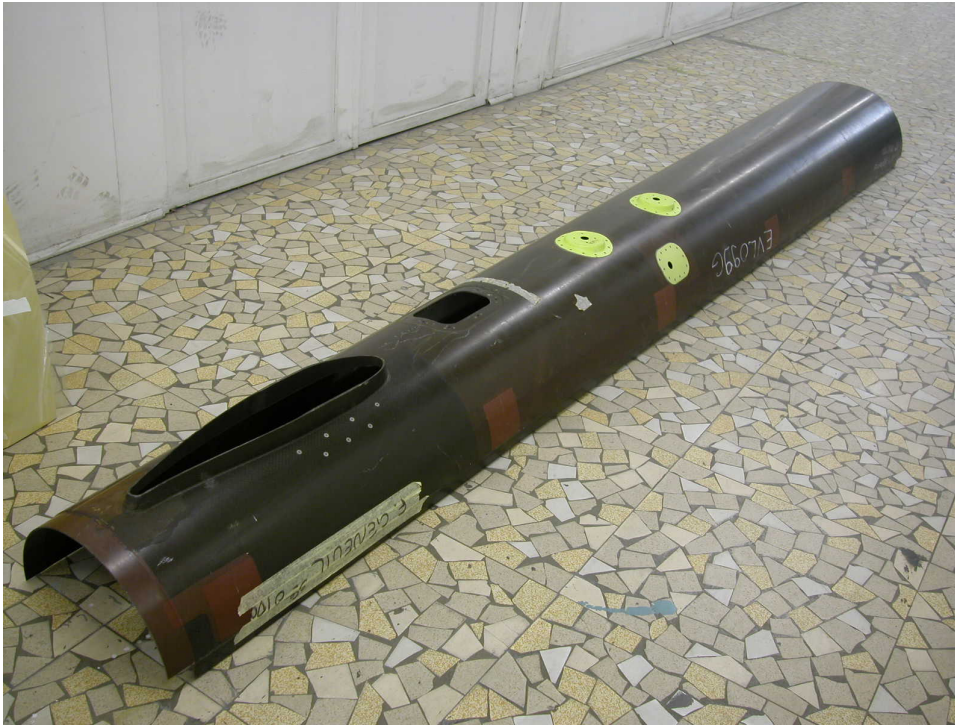
**Fig. 20 Photographs of the demonstrator**

In this work package, the achievements from the laboratory tests on small samples are transferred to a real large scale component. A tail boom demonstrator of the EC 135 was selected for the full-scale test by Eurocopter France. It is a specimen with complex setup and various discontinuities like inserts, holes and both artificial and impact-induced defects.

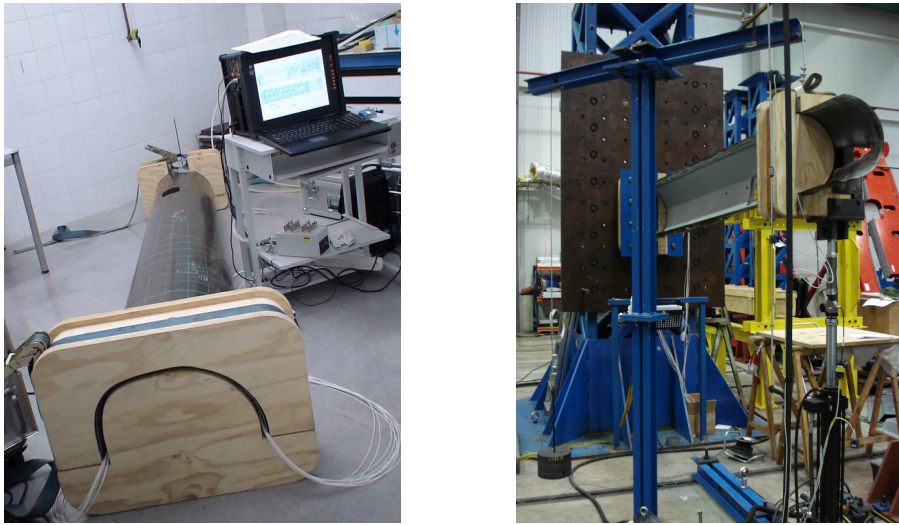
**Fig. 22 Preparation (left) and execution of the large scale test at CTA**

The large scale test was performed at CTA (Fig. 22), Spain. Before, the tail unit was equipped with rectangular piezo patches. During the test, transmitters T1-T8 and receivers R1-R8 were in use.

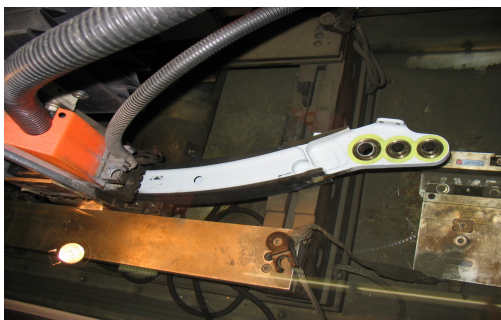
Fig. 29 Slat-track of an AIRBUS A320 mounted in an spark erosion facility. The red circle marks the position of the wire (unvisible at this foto)

A real slat track was mounted into another spark erosion facility and the response of the acoustic signal was recorded with a set-up very similar to the experiment described before. The response was measured at different frequencies.

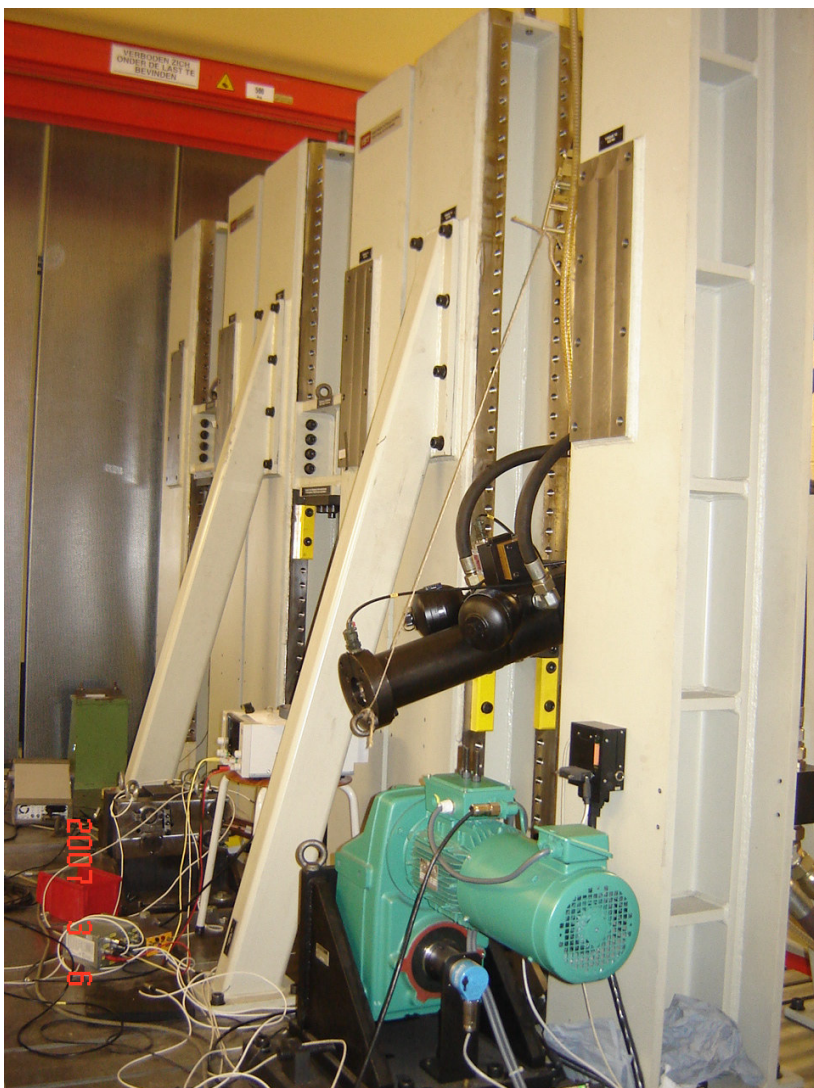
Fig. 32 Test rig of ASCO at the VUB (Free University of Brussels). In the foreground, a bi-axial test rig can be seen.

The test was performed using an uni-axial test rig and here, and the sensor connection was ensured during the whole process, such as proven by measurements of the electric impedance of the sensors. Also in this case, the growth of the crack was visible by a strong response of the ultrasonic signal. The tests are still in progress and therefore, not all results are available at the moment. A particular feature of this measurement is that the cracks are only open if the slat track is under load. This corresponds to operational conditions, where potential cracks would only be open during the start and landing of the aircraft. Therefore, ultrasonic measurements were performed under load and without load to get information on both cases.
