## **Summary Report on the Technical Tasks**

*LIGHTNING-Culham-TN(08)-05 Open*

## **LIGHTNING-CULHAM-TN(08)-05Open**

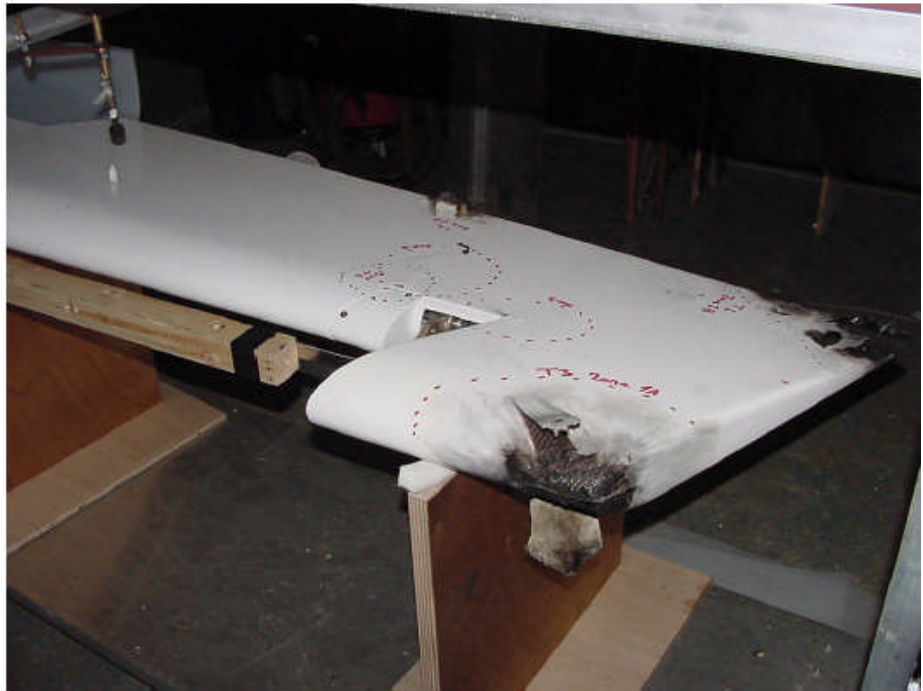
One of the large scale structural test items (full rudder) having lightning protection for several different lightning zones.

Tests were to Zones 1A, 1B, 2 and here with the electrode located for a Zone 2A test.

Dotted lines near the upper hinge indicate minor effects at the cured bonding strips.

Damage is superficial

manufactured by Grob (Germany) and Evektor (CzechRepublic). None of these large samples punctured, and surface damage was consistent between the samples. The biggest concern was that full scale samples might exhibit different failure mechanisms such as major trailing edge splits, but this did not happen.

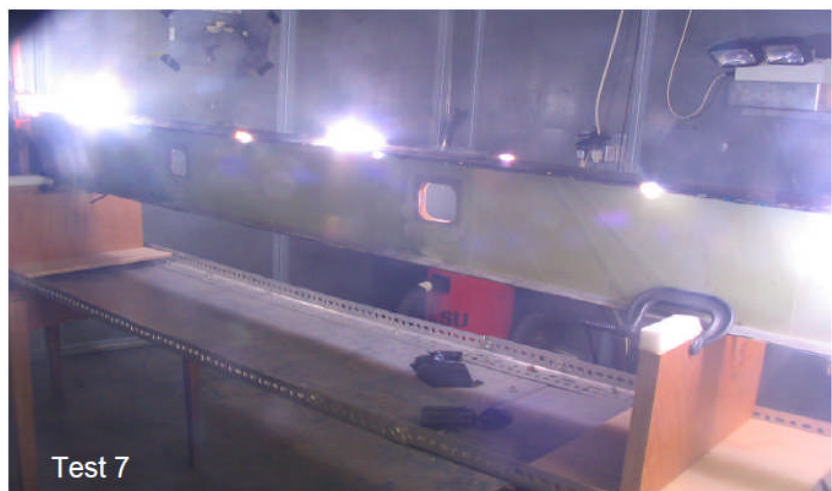
High level conduction test to instrumented wing spar. Here arcing is occurring between external skin plies and the spar caps

A full scale wing spar sample was manufactured by AEL which incorporated a fibre optic strain gauge. Lightning currents were conducted along the spar at increasing levels, with the wing spar strain under load monitored after each test. At high current levels these strain measurements indicated spar degradation; the degradation in strength appeared to be caused by local interply delaminations.

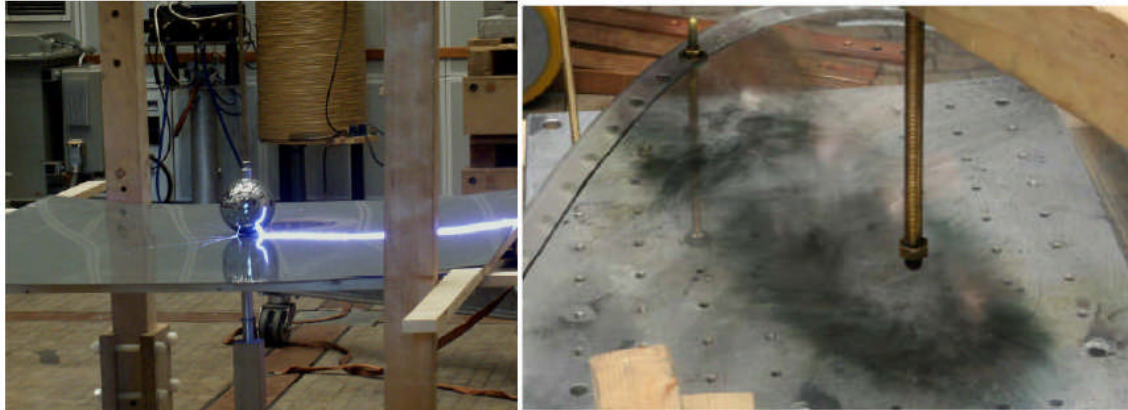
Figure 47: Windscreen surface after the tests

Testing of plexiglas sample showing HV flashover around edges (left). At right is a high current test to a windscreen sample, no shock damage from the arc occurred..

For the windscreen plexiglass (1mm) the samples could easily hold off 70kV, but at higher voltages the arc simply tracked around the edge of the 1m square sample. Puncture was eventually achieved by immersing the sample in oil. When the windscreen incorporates heater mats these appeared to act as stress-raisers and breakdowns occurred at significantly lower levels. Breakdowns were also shown to be possible at points where windscreen or canopy cracks had been repaired; these regions are shown
