**Figure Error! No text of specified style in document.-1 Multiplexed TGT Measurement**

**Figure Error! No text of specified style in document.-2 Proposed Data Acquisition Subsystem**

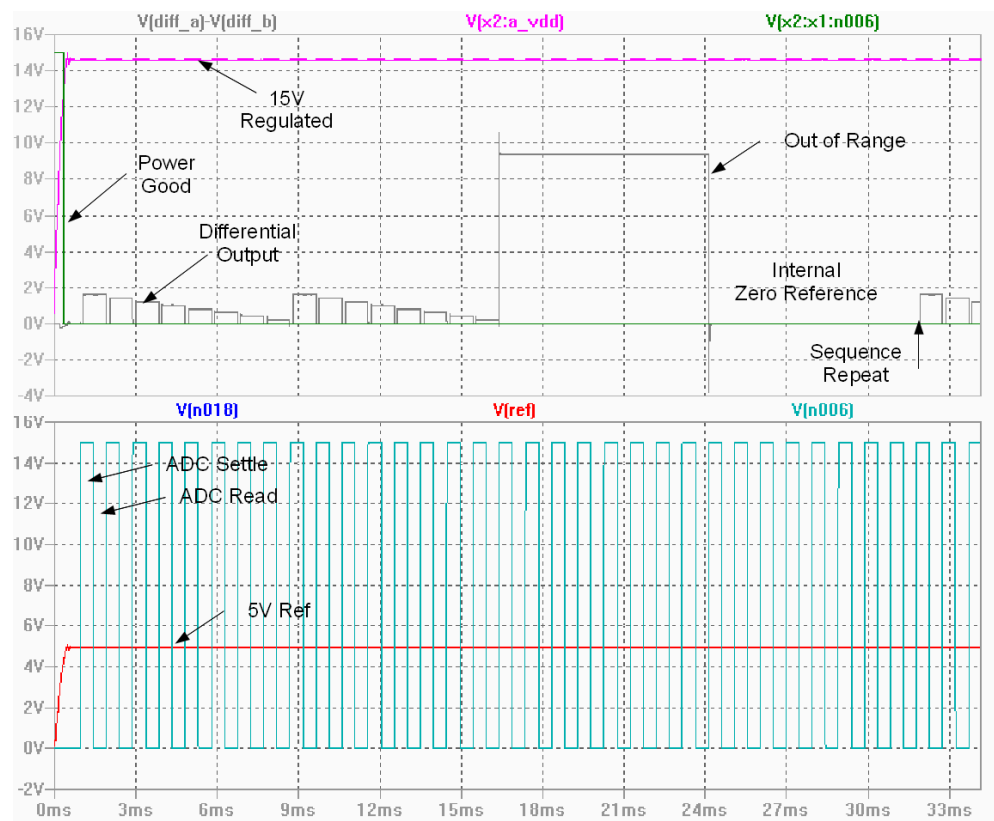
**Figure Error! No text of specified style in document.-3 Simulated Waveforms of the Design Concept**

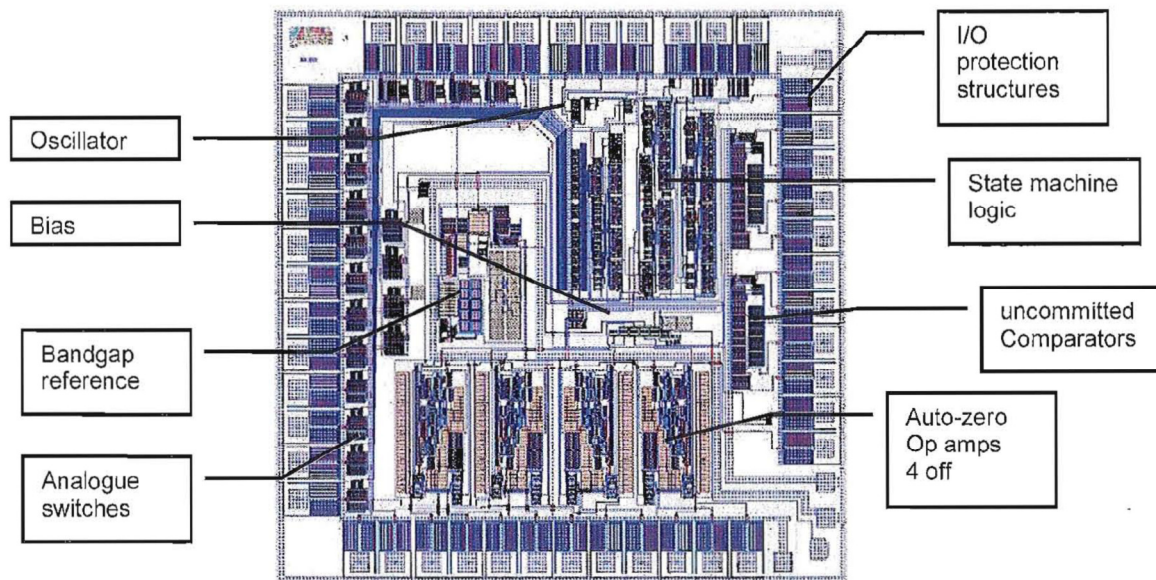
**Figure Error! No text of specified style in document.-4 Final SiC IC Layout Showing Major Functional Blocks**

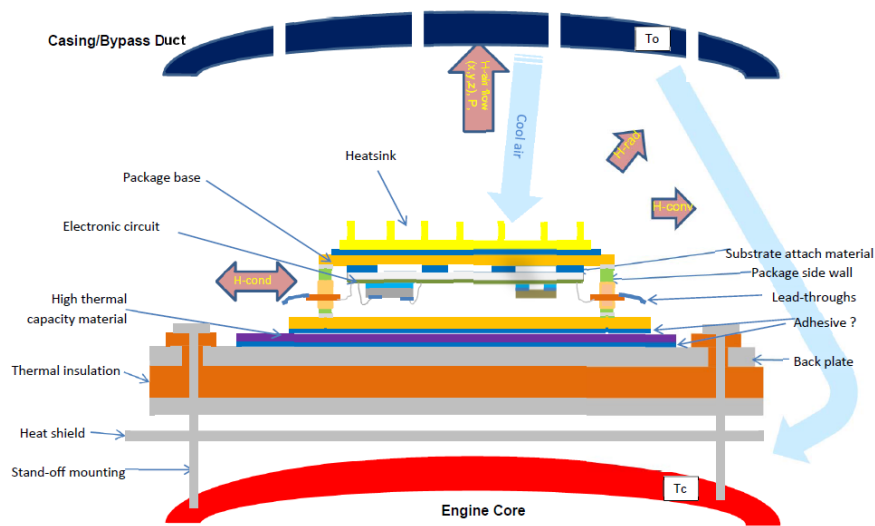
**Figure Error! No text of specified style in document.-6 Schematic of Thermal Management Concepts**

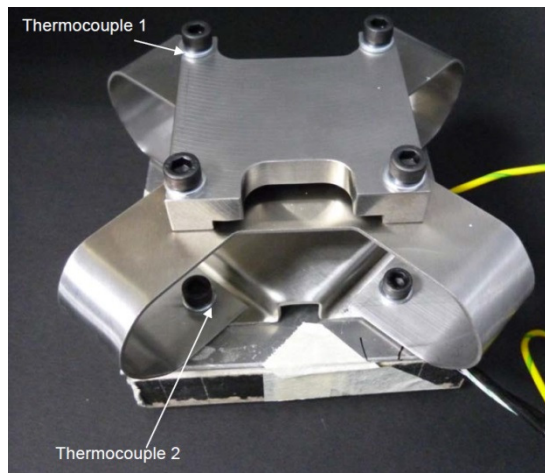
**Figure Error! No text of specified style in document.-7**  
**Wind Tunnel Test Sample**

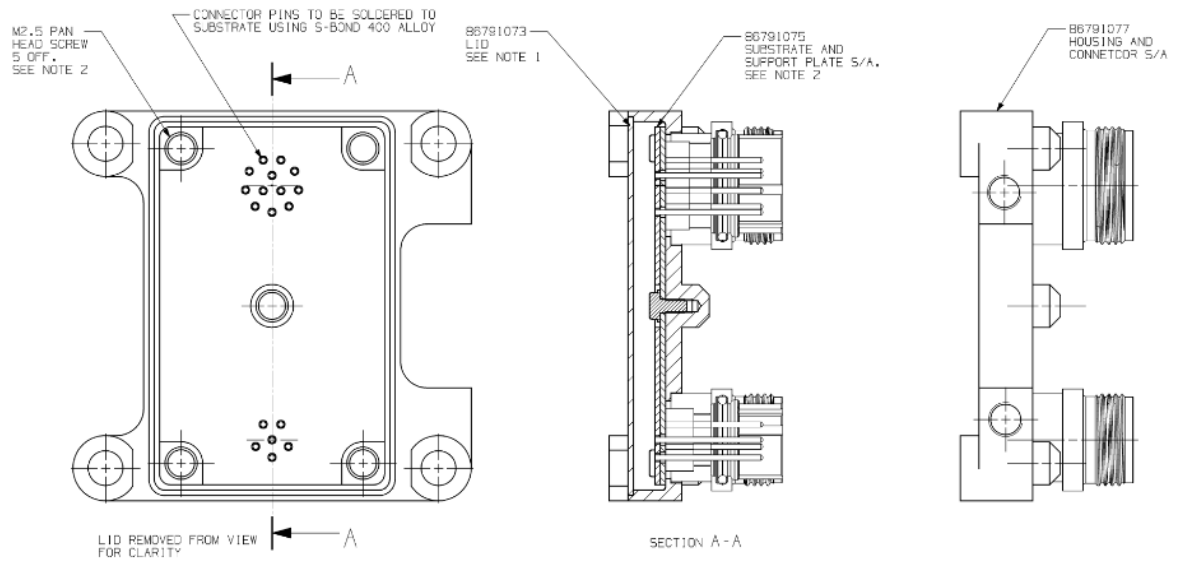
**Figure Error! No text of specified style in document.-8 Mechanical Demonstrator Design (86791078)**

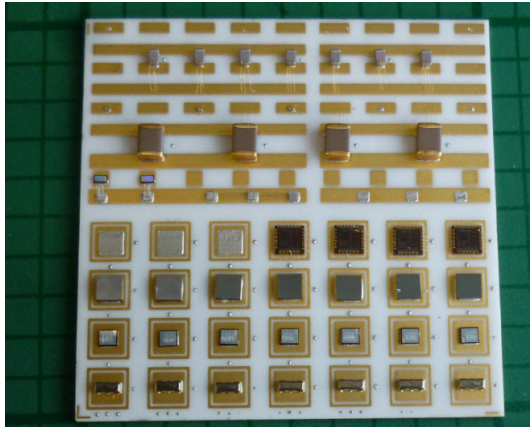
**Figure** Error! No text of specified style in document.-9

**Material Selection Test Substrate**

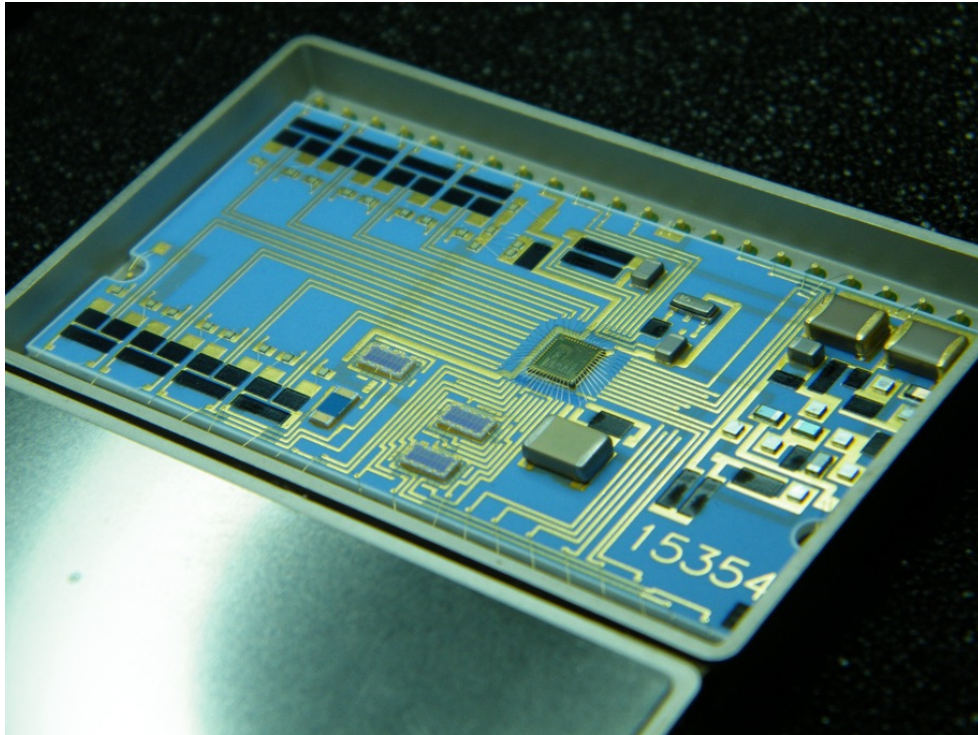
**Figure** Error! No text of specified style in document.-10 **Electrical Demonstrator**

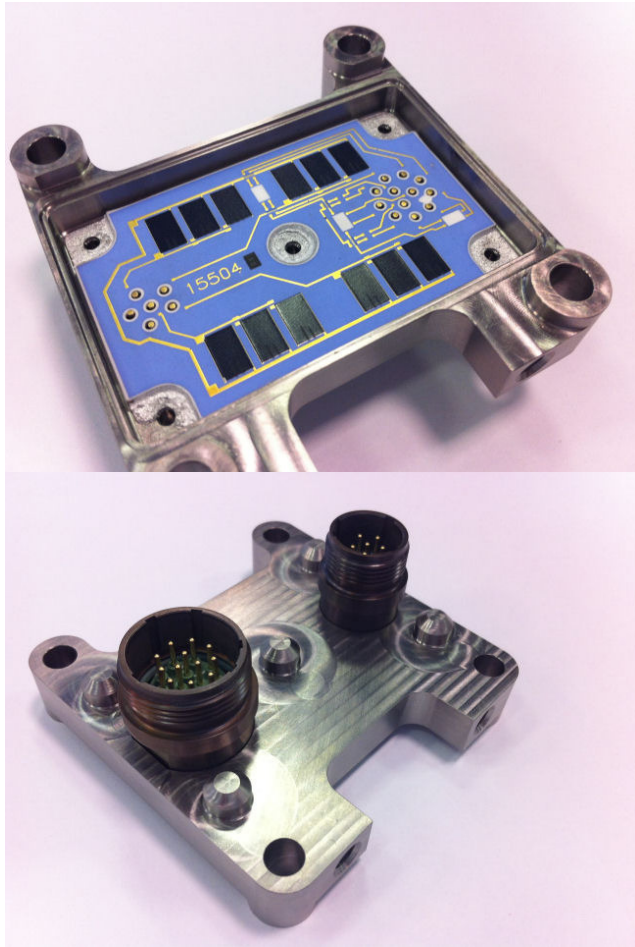
**Figure** Error! No text of specified style in document.-11 **Mechanical Demonstrator**

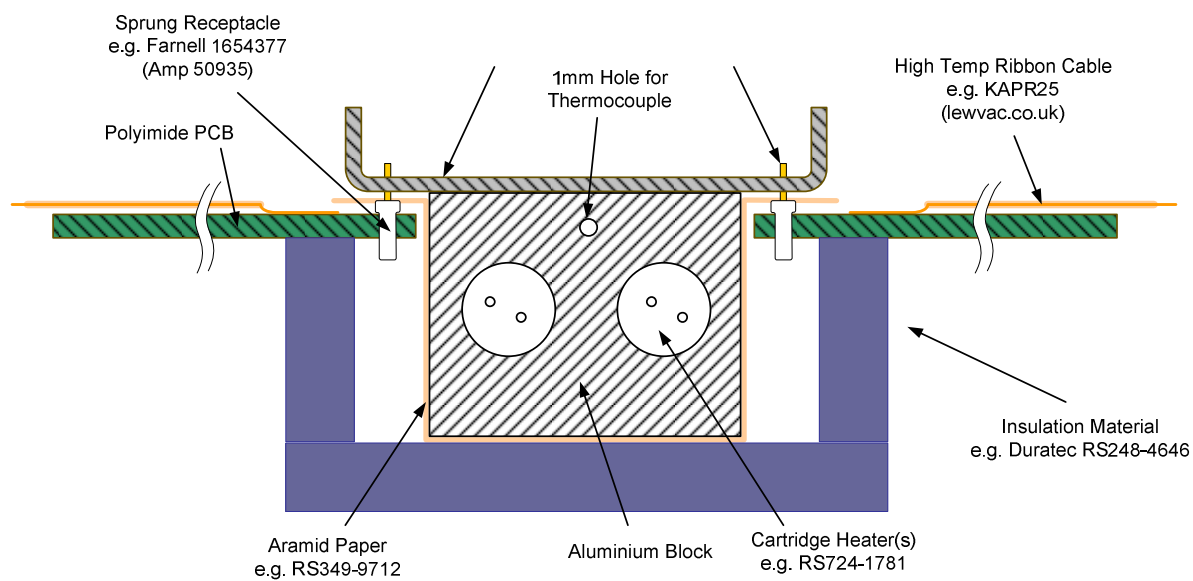
**Figure Error! No text of specified style in document.-12 Electrical Demonstrator Test Interface**

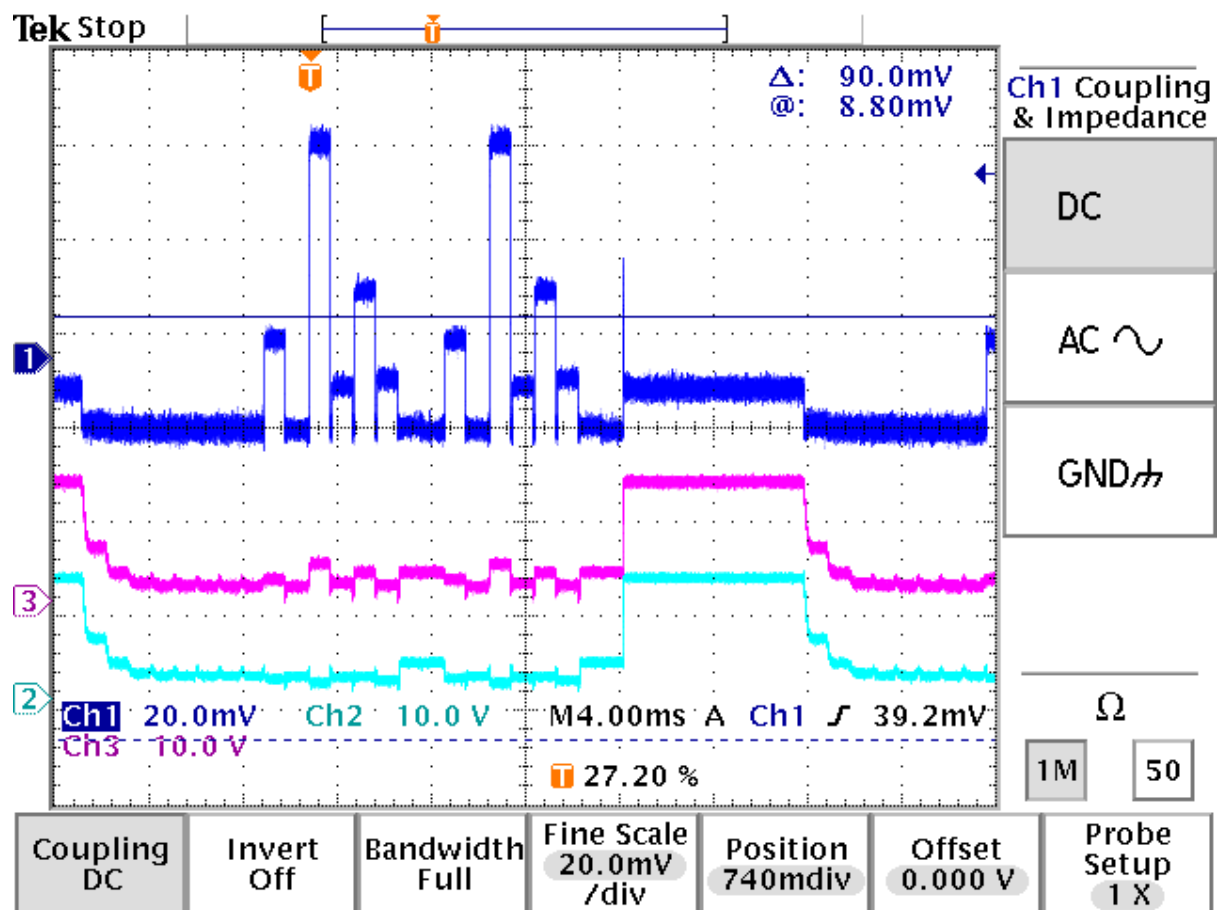
Figure Error! No text of specified style in document.-13 Electrical Demonstrator Test Waveforms at 200 °C
