## PVCROPS LOGO

## Pictures to promote the work

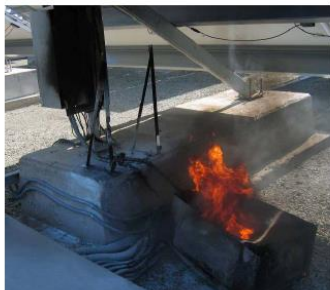
Figure 115.

A very poor practice involves opening a fuse holder under load as this creates a serious risk of electrical shock and destruction of equipment. DC circuits must be de-energised before any intervention is made. Figure 115 shows the consequence of opening a fuse carrying a DC current of approximately 40 amps. An electric arc developed between the fuse sides and caused a fire inside the box, leading to the destruction of the connection box. Fuses are a form of protection which cannot be opened under load and therefore special load breaking switches that are designed to open the circuit under load are used (see next pages).

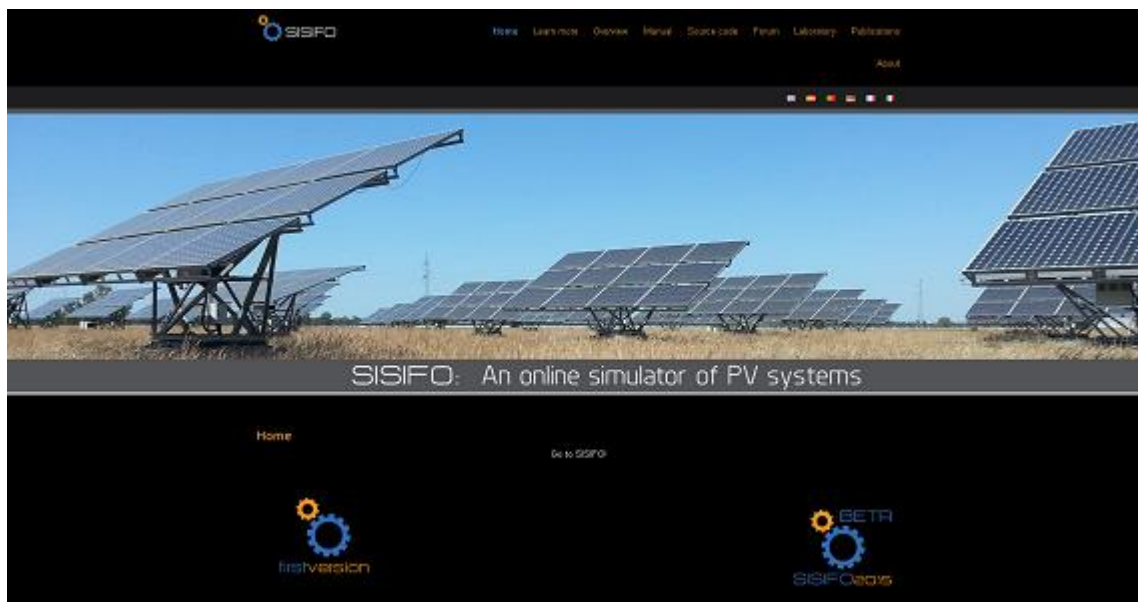
**Figure 4.** Home page of SISIFO, the free and open-source simulation tool developed in PVCROPS and available at [www.sisifo.info](http://www.sisifo.info)

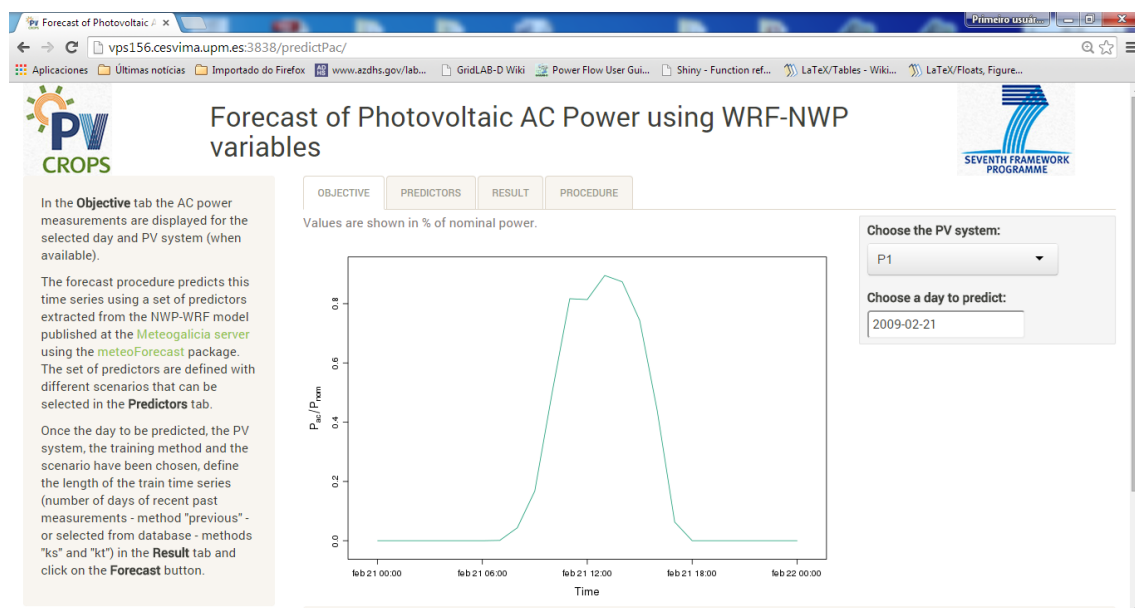
**Figure 5.** Home page of PROPHET – prediction of PV production, the free and open-source simulation tool developed in PVCROPS and available at <http://vps156.cesvima.upm.es:3838/predictPac/>

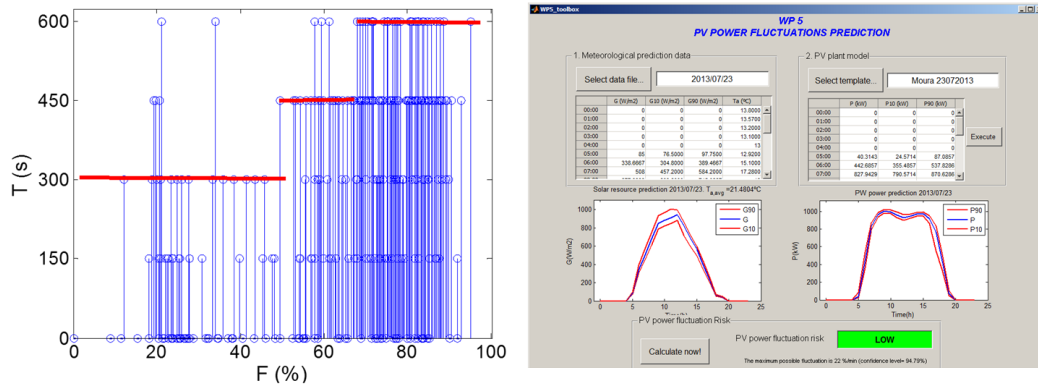
**Figure 6.** Toolbox to simulate the variability in the power generated by a group of large dispersed PV plants.

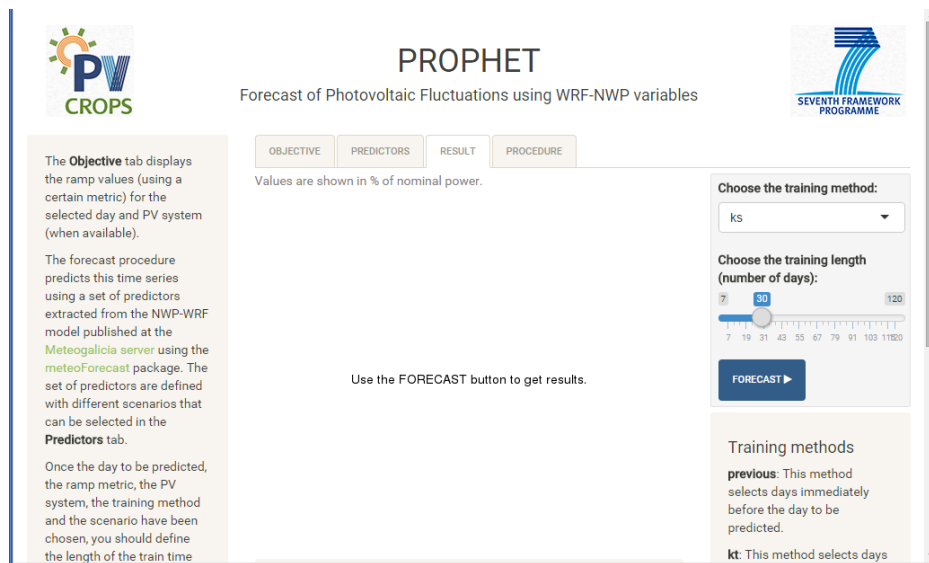
**Figure 7.** Home page of PROPHET – prediction of PV power fluctuations, the free and open-source simulation tool available at <http://vps156.ces.vima.upm.es:3838/predictRamps/>

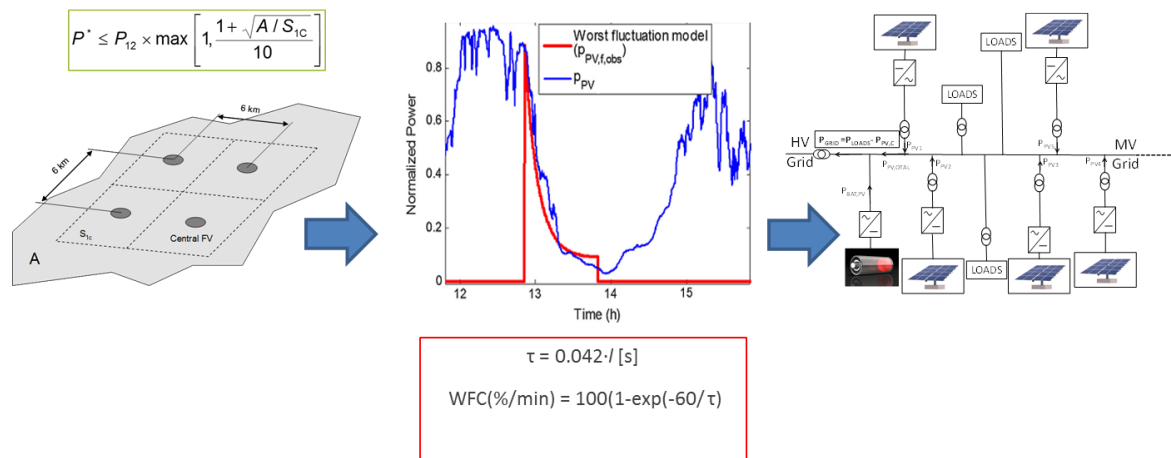
**Figure 8.** Toolbox providing guidelines for the integration of PV plants into the grid.

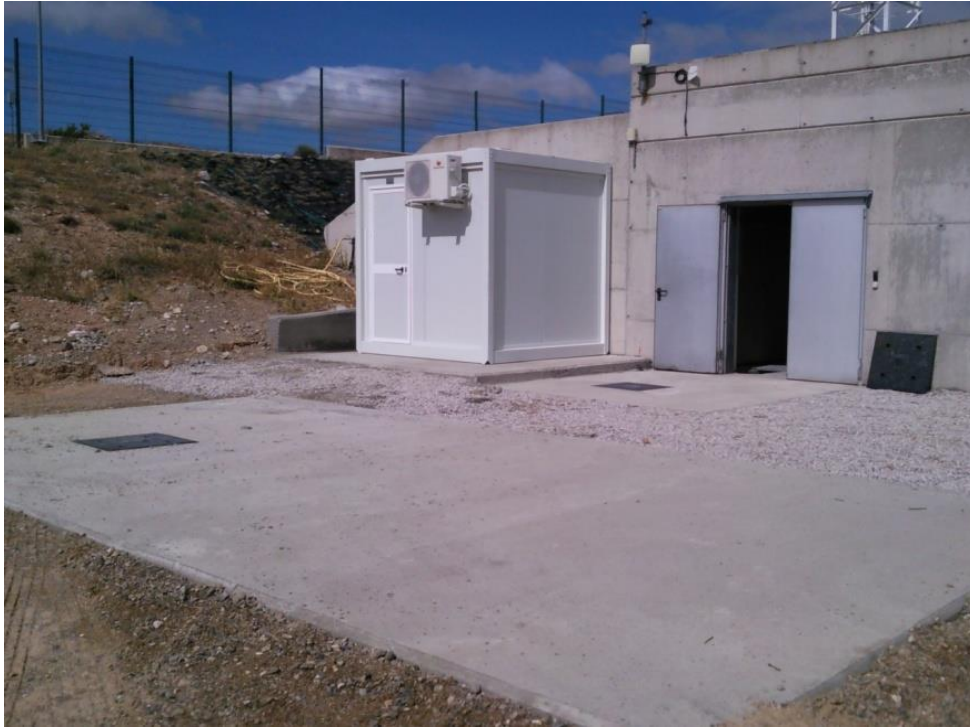
**Figure 9.** Lithium ion energy storage system installed at Tudela PV plant

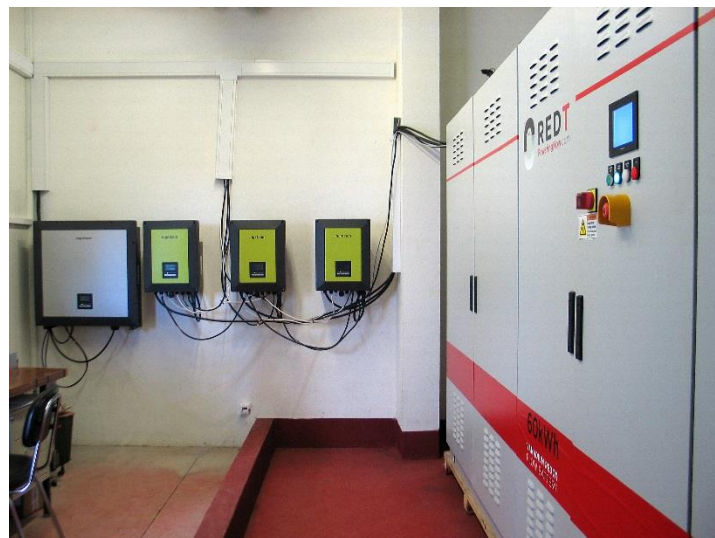
**Figure 10.** VRB system installed at Évora's university.

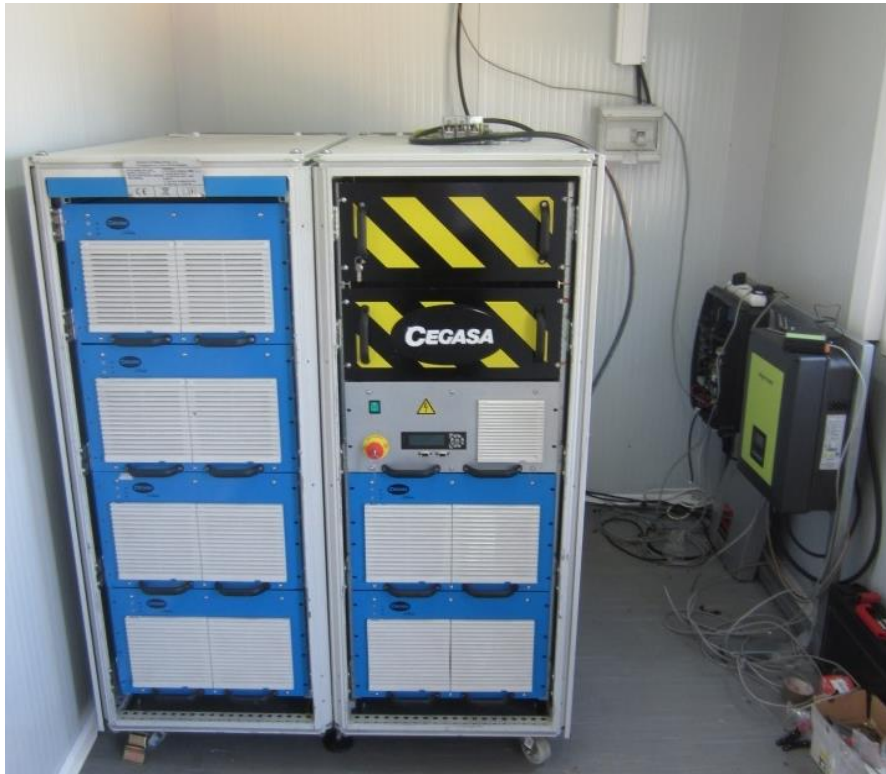
**Figure 11.** Li-ion demonstrator at University of Évora. Ingeteam's power inverters on the right and lithium-ion battery on the left.

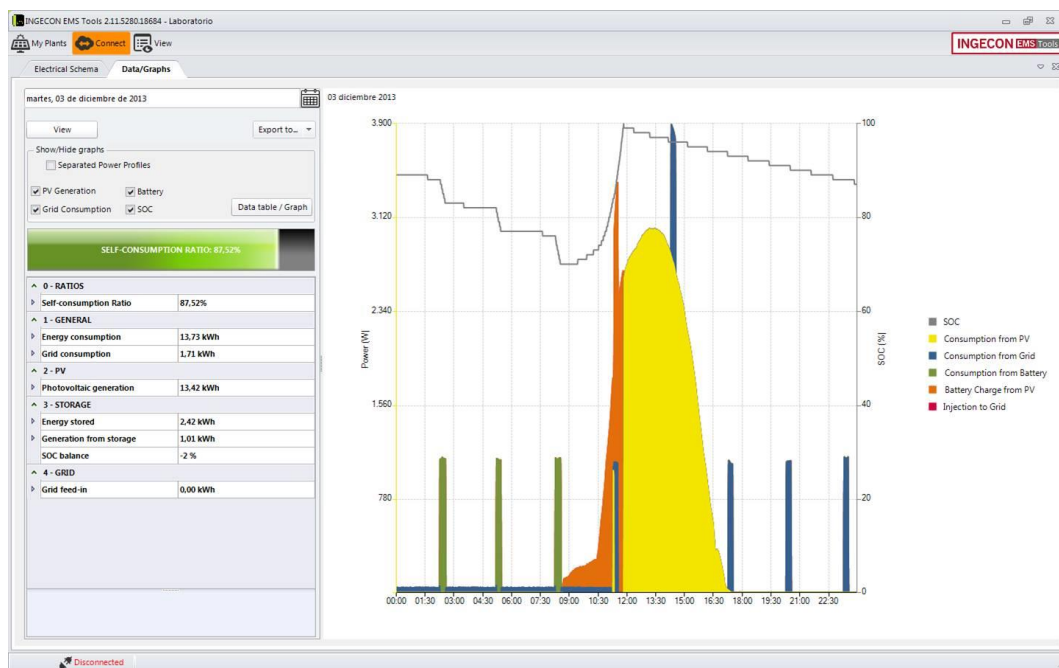
**Figure 12.** EMS Tools screenshot.

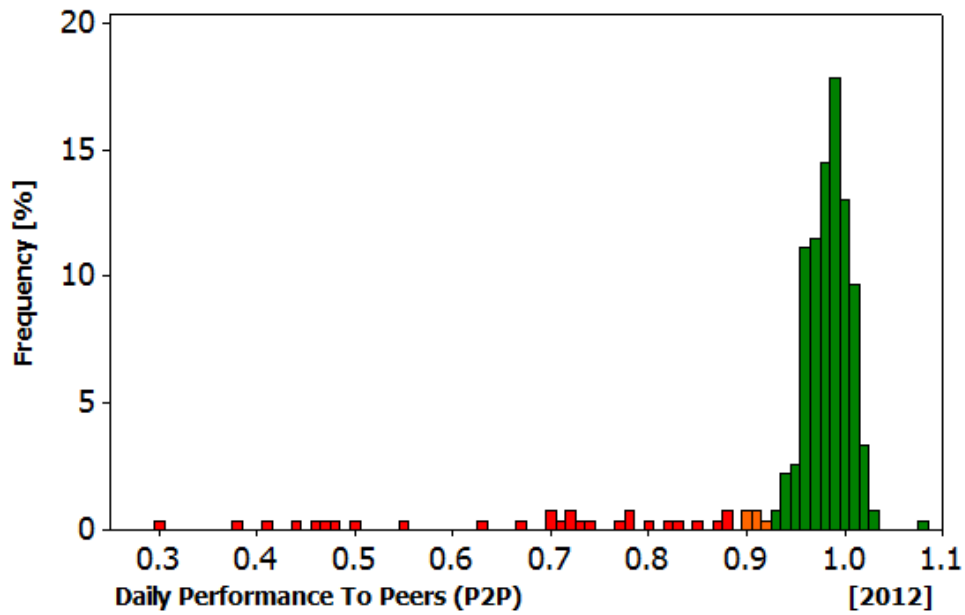
**Figure 13.** Histogram of daily  $P2P$  on a BIPV system during the whole year 2012. The green bars are representative of the normal operation of the PV system. The red bars are probably due to performance problems. The orange bars correspond to an intermediate zone where there is an overlap between the two populations.

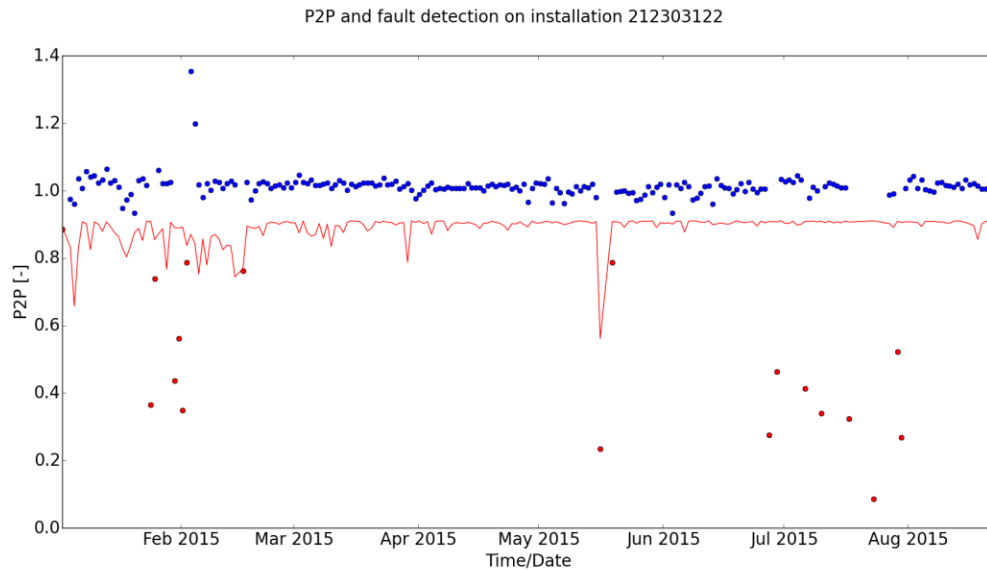
**Figure 14.** Daily  $P2P$  of one PV installation located in Belgium from January to August 2015. The  $P2P$  values corresponding to days that were free of faults (blue points) are generally stable over the year. The variability is generally higher during the winter. The fault detection threshold (red line) is high overall, but decreases during the days whose sky conditions are more unstable. The red points correspond to  $P2P$  values that are below the threshold and that were attributed to faults.

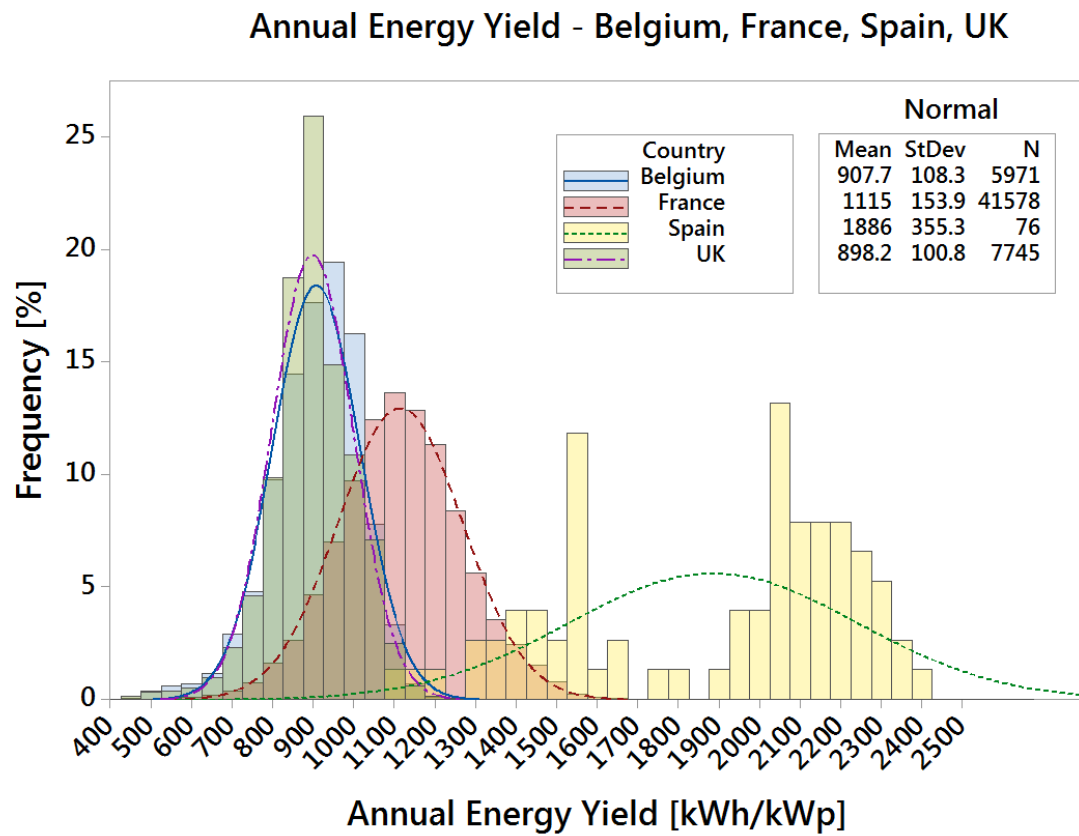
**Figure 15.** Annual Energy Yield obtained on the data analysed from four key countries of Europe: Belgium, France, Spain, and the UK.

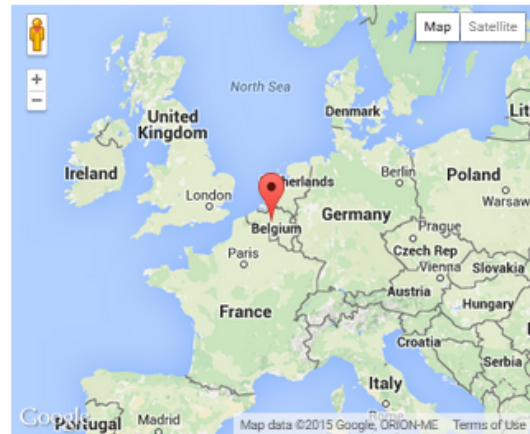
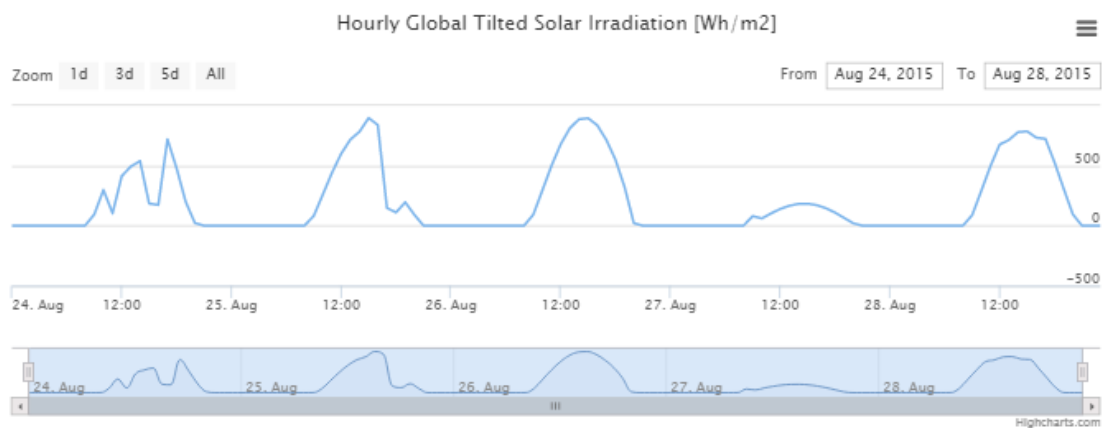
**Figure 16.** SOWEDA tool and its web interface to retrieve the solar irradiation in Brussels from the 24<sup>th</sup> to the 28<sup>th</sup> of August 2015 ([www.soweda.net](http://www.soweda.net)).

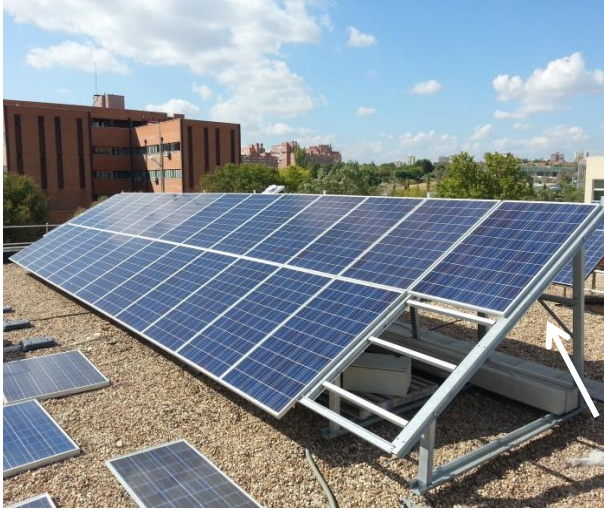
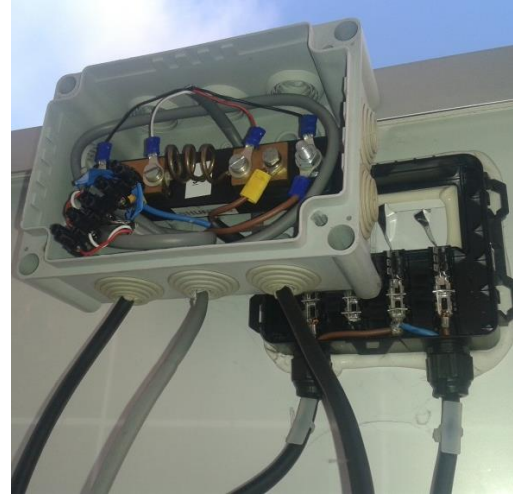
**Figure 17.** Testing kits: (a) Single reference module that has been modified to measure simultaneously both  $G_{ef}$  and  $T_C$ . (b) Connection box added to the module with the shunt resistor and the wiring to get both signals simultaneously (in the module's junction box can be noticed the internal modification).

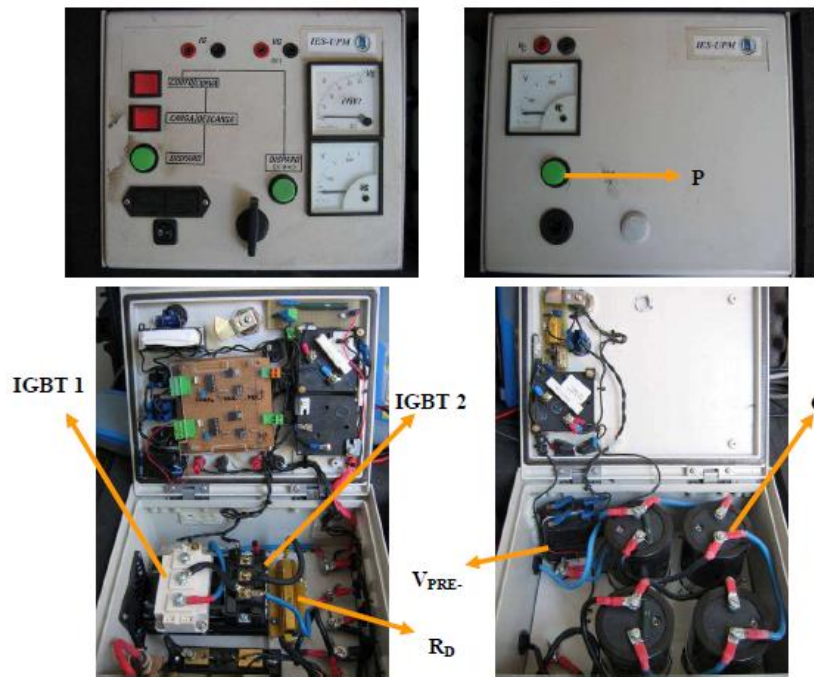
**Figure 18.** Testing kits: External and internal views of the first capacitive  $I$ - $V$  curve tracer implemented by the IES-UPM. Left box contains the IGBTs and the driver and supply circuits. Right box contains the capacitors and the negative pre-charging circuit.

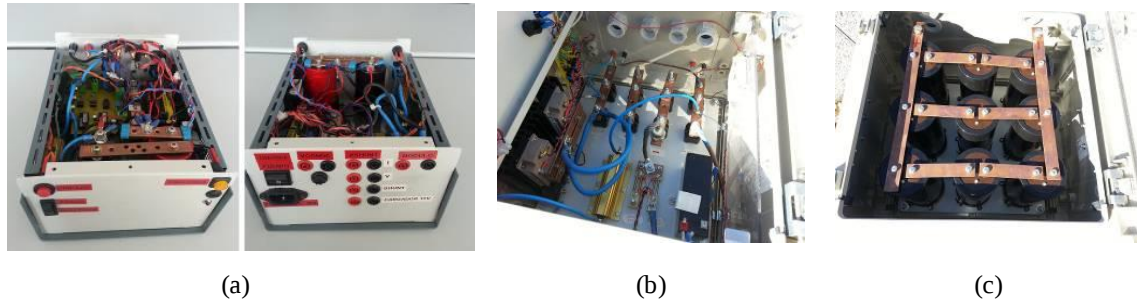
**Figure 19.** Testing kits: (a). View of the  $I$ - $V$  curve capacitive tracer implemented by the IES-UPM specifically designed to measure individual PV modules. It includes all the required devices and circuits in a single box. (b). View of the  $I$ - $V$  curve capacitive tracer implemented by the IES-UPM specifically designed to measure large PV arrays up to 2 MW. This box includes the IGBTs, the driver circuit, the supply circuit and the negative pre-charging circuit. (c) View of the one of the boxes with the capacitors for the  $I$ - $V$  curve tracer of picture b.

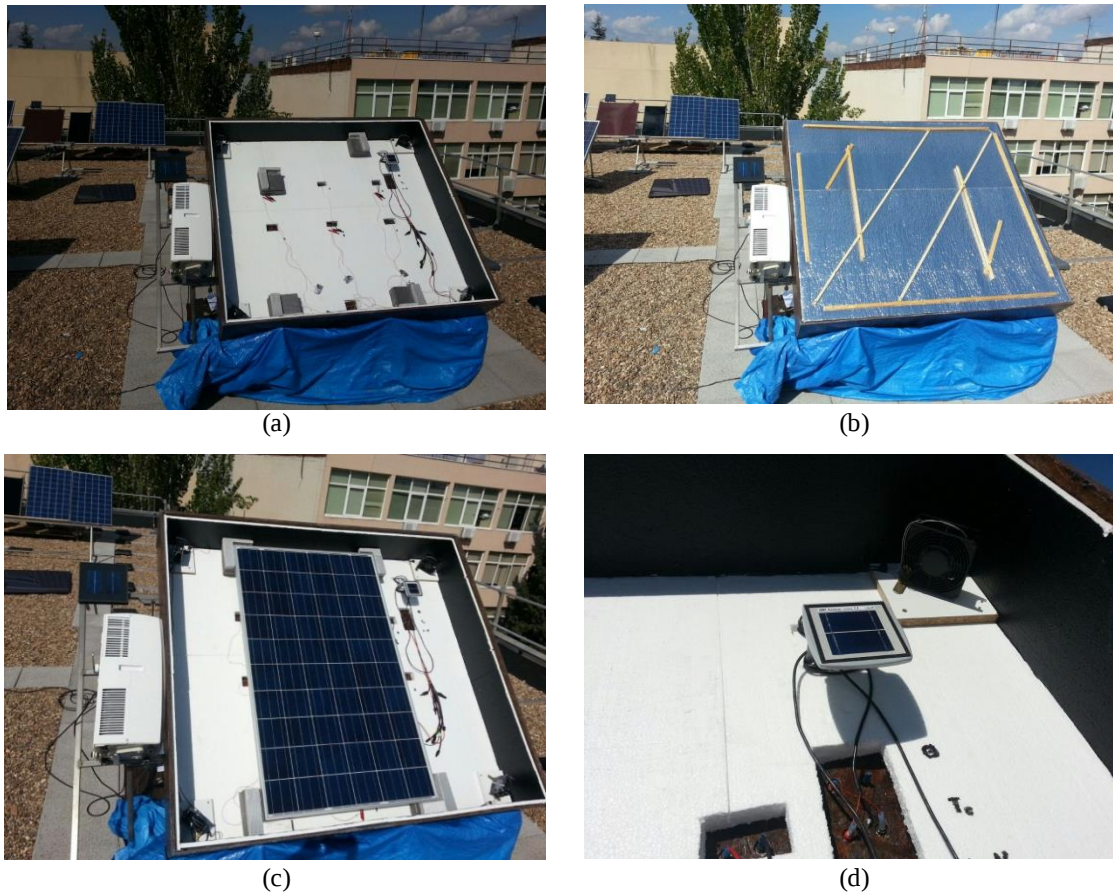
**Figure 20.** Testing kits: Climatic box used for testing PV modules outdoors. This second version is made of wood and it is filled with white polystyrene to decrease the heating of the whole box once the cover is removed (a) Climatic box opened, with the PT1000 sensors, the fans and the internal reference solar cell inside. (b) Before the test, the PV module is placed inside the thermally insulated box, the inside temperature is forced to 25°C by means of an air conditioner and the box is manually positioned to reach incident irradiance close to 1000 W/m<sup>2</sup> thanks to the external reference solar cell (c) The cover is removed and  $I$ - $V$  curves are recorded at 25°C and also along the natural heating process. (d) Detail of the fans and the internal reference solar cell.

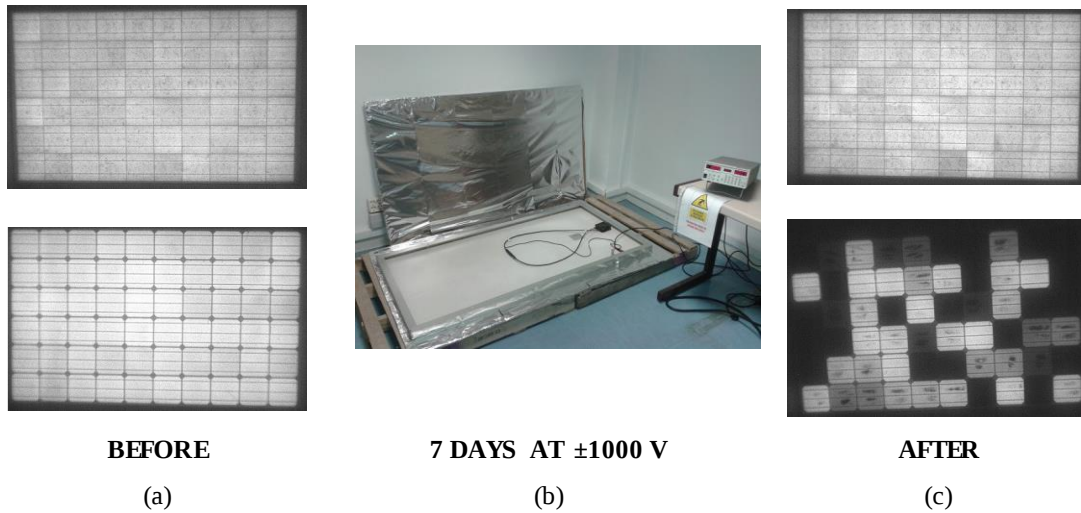
**Figure 21.** Testing kits: Accelerated test to degrade modules in the laboratory. (a) First, the EL image of the module is taken. (b) Then, a voltage of  $\pm 1000$ V is applied between the short-circuited active poles and the frame of the module, once its front surface has been covered with an aluminium foil. (c) Finally, after a period of 7 days the EL image of the module is taken again. If the module is prone to PID phenomenon some of their cells become inactive (dark ones, down module).

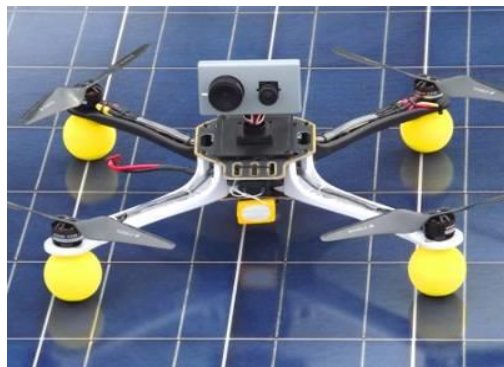
**Figure 22.** Testing kits: First version of the developed quadcopter (PV drone). It has an IR camera and a visible camera for monitoring a PV installation.

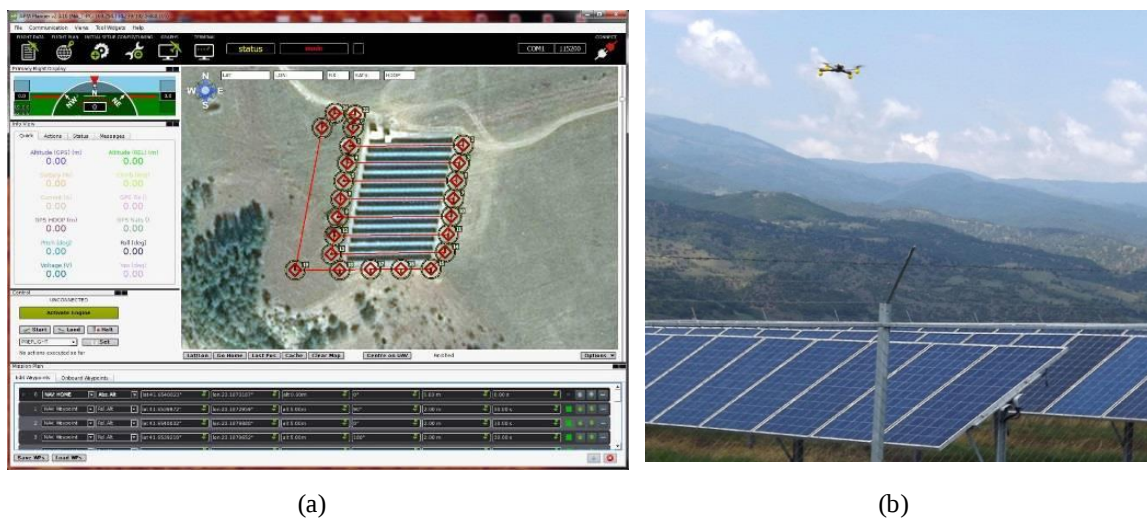
**Figure 23.** (a) Quadcopter flying mission planned for a 150 kW PV plant. (b) Quadcopter during the inspection flying mission above the array PV modules.

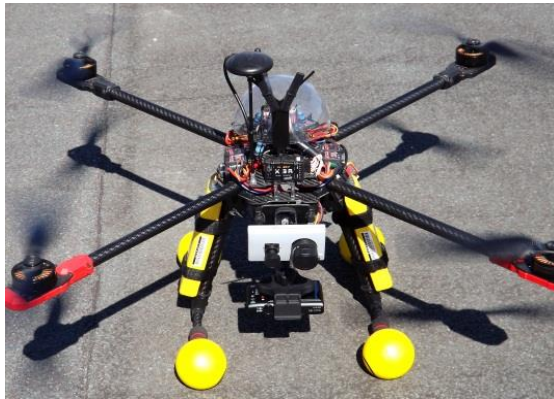
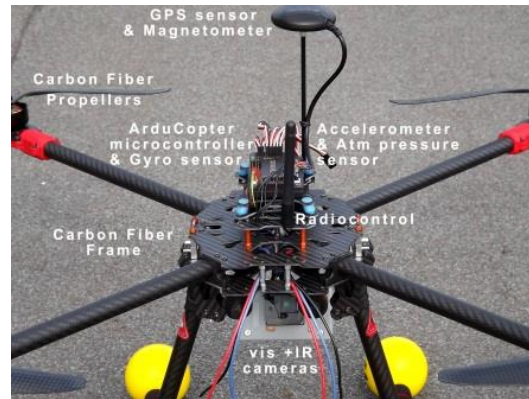
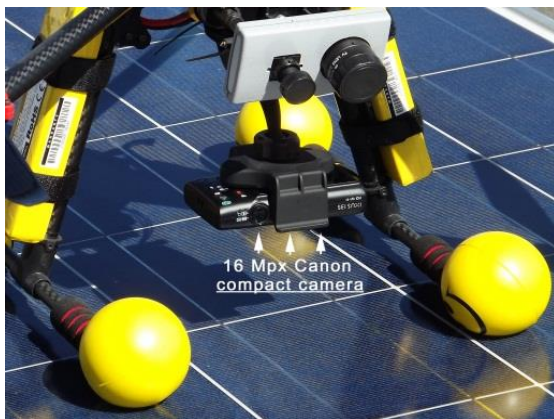
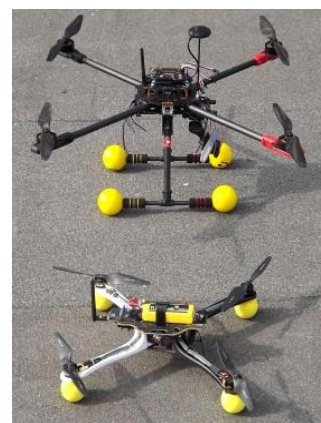
**Figure 24** Testing kits: (a) and (b) PV drone configuration enabling 3-D mapping missions. (c) IR camera and visible camera for monitoring a PV installation and compact digital camera for photogrammetry analysis. (d) UAVs developed by PVCROPS team (CLSENES)

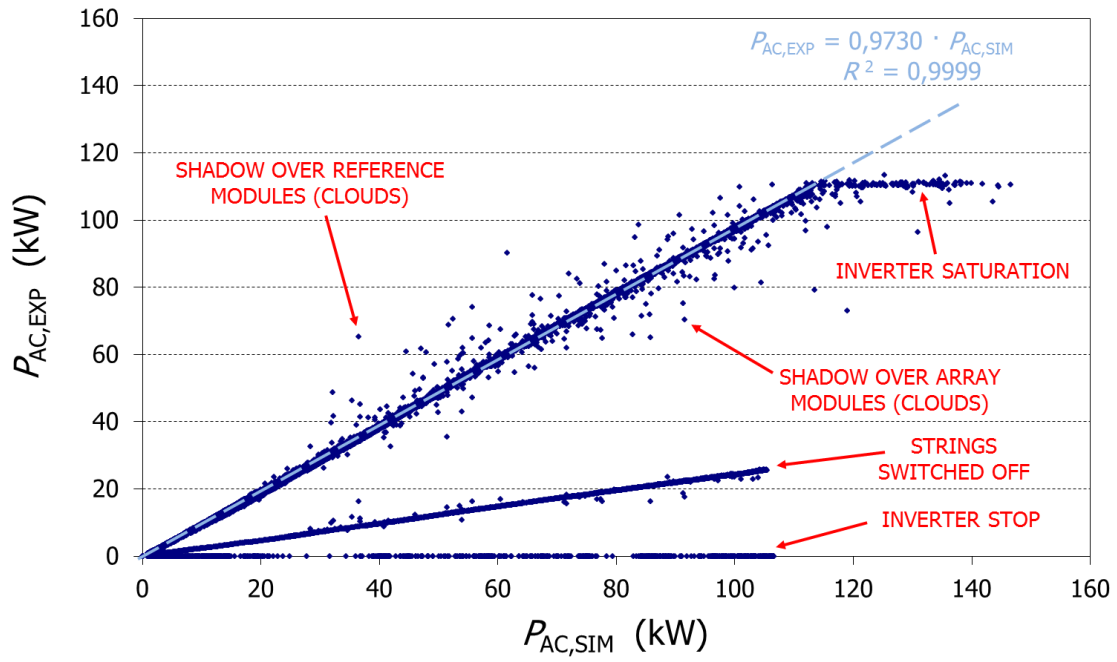
**Figure 25.** Testing kits: AC power response of a 110 kW nominal power PV array measured on-site with a watt-meter. The normal operation is represented by the linear dotted behaviour. The other anomalous situations can be noticed in the graph: shadow over sensors or over PV array modules due to clouds, strings switched off, inverter saturation and inverter stop.

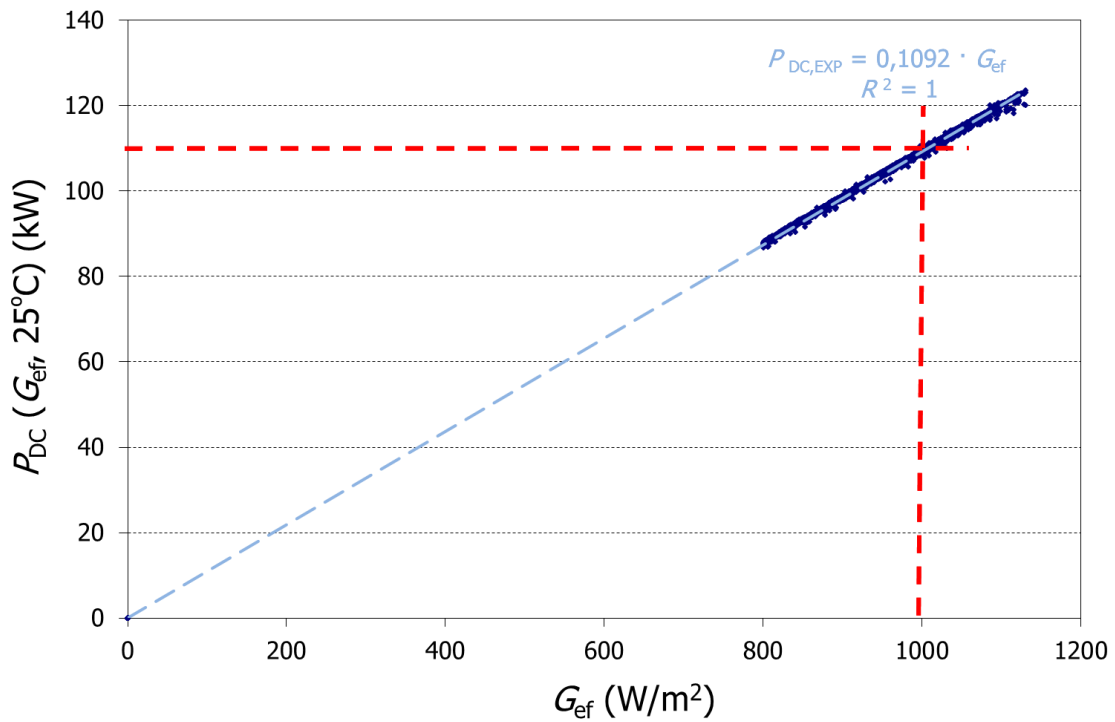
**Figure 26.** Testing kits: DC power corrected at 25°C of a 110 kW nominal power PV array measured on-site with a watt-meter. The DC power records related to anomalous situations and to low irradiances have been previously removed to obtain the DC peak power value at STC.

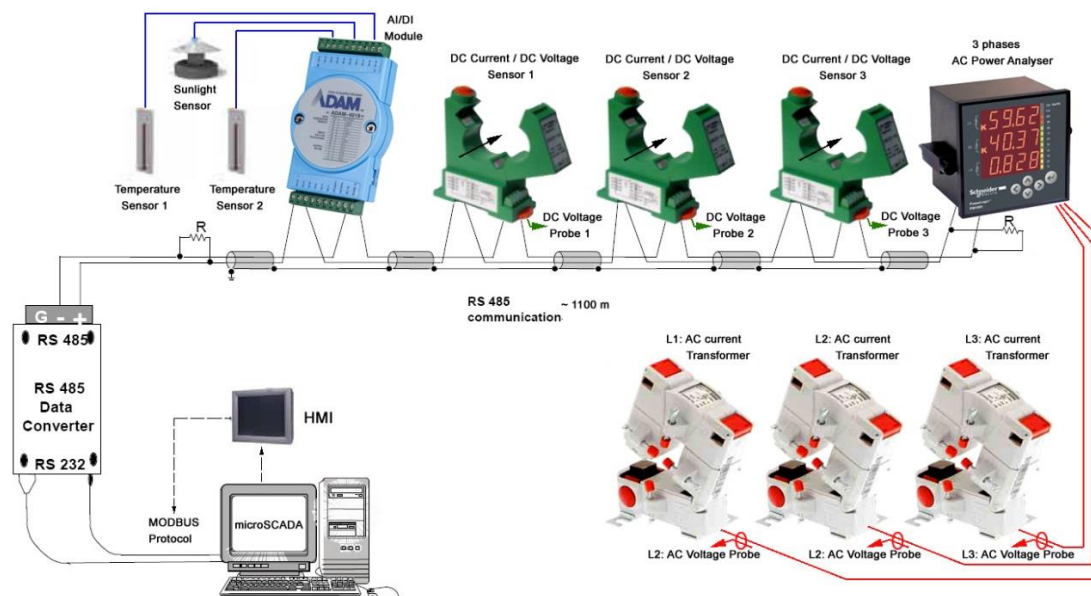
**Figure 27.** Testing kits: Low cost portable SCADA scheme for DC and AC measurements, as well as operating conditions measurements.
