COOP-CT-2004-508442
ECO SOIL
INNOVATIVE PROCESS FOR THE ON-SITE DECONTAMINATION OF SOILS

CO-OPERATIVE RESEARCH PROJECT

REPORT
FINAL ACTIVITY REPORT

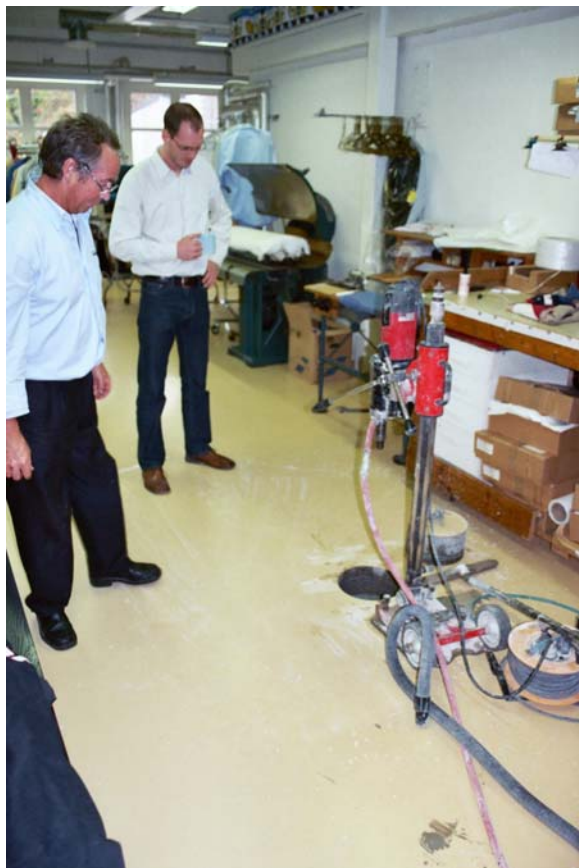
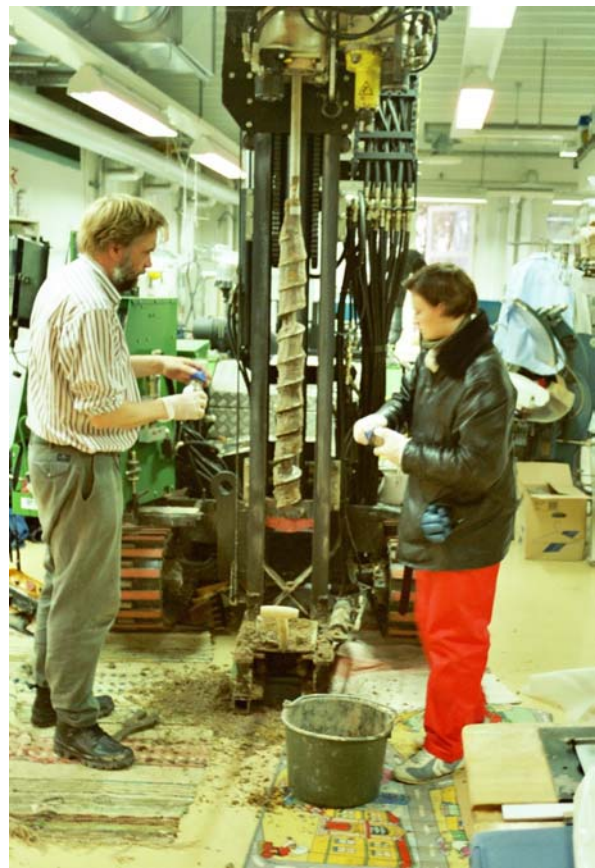
Figure 3: Drilling and sampling inside the factory (location 402)

However, almost 85% of the site has mineral oil pollution below 200 mg/kg. The other 15% of the samples refer to 4 sampling points, i.e. point 402 (2x), 405 (2x), 407 and 409. The highest concentration was found at point 402 in a depth between 2,8 and 2,9 m.

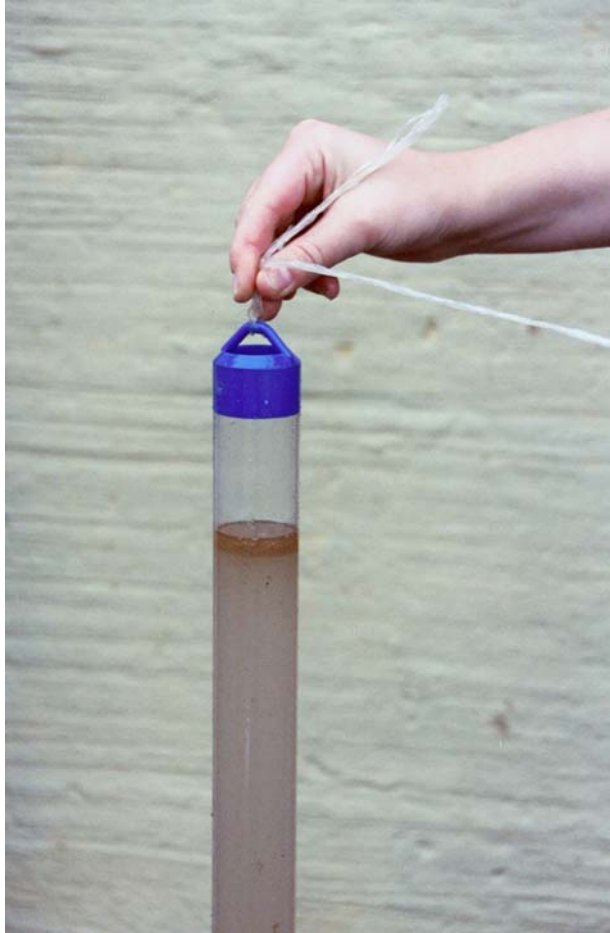
Figure 4: Groundwater with oil layer

The analysis of the different groundwater samples regarding mineral oil hydrocarbons shows that 1 of the groundwater samples exceeds the German test value by the factor ~ 2 while 1 sample exceeds it by the factor ~ 58.000 (!!!). In the remaining samples no mineral oil could be found (detection limit: 0,2 mg/l).

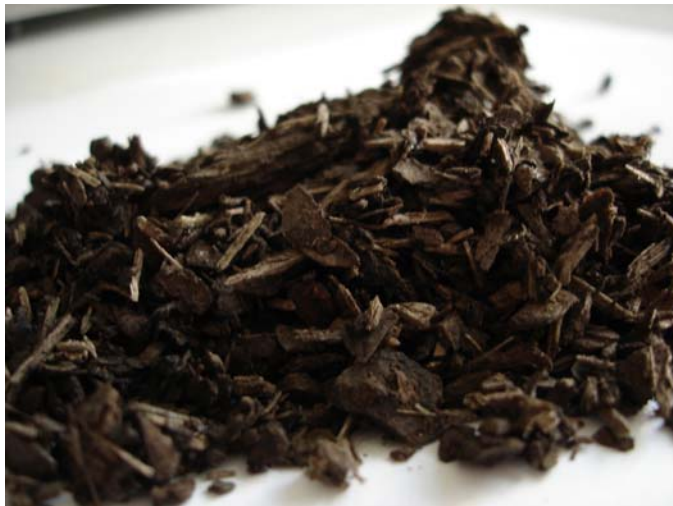
Figure 5: Modified pine bark after three month use in Ecosoil system

Further more the issue of the reutilisation was investigated. Since the modified pine bark has proven as the best performing sorbent these investigations where only done for pine bark. The results were that for mineral oil hydrocarbons pollution the sorbents could be easily reused after biodegradation under controlled conditions, however, for chlorinated hydrocarbons it wasn't an efficient procedure since they are highly volatile and must be also degraded as a co metabolite by adding other pollutants to the sorbent. All other proposals only show that the poison can only be shifted from one location to another where they will stay. However, if environmental problems with volatile chlorinated hydrocarbons were not taken into consideration and/or a different soil in a different place was not contaminated with those, the sorbents could always be reused with no restrictions.
